UAS AAK'W SHORELINE IMPROVEMENT PROJECT CONCEPT/SCHEMATIC DESIGN SUBMITTAL

24 May 2019

Project: UAS Aak'w Shoreline Improvement Project
UAS Contract/Project #2015-08

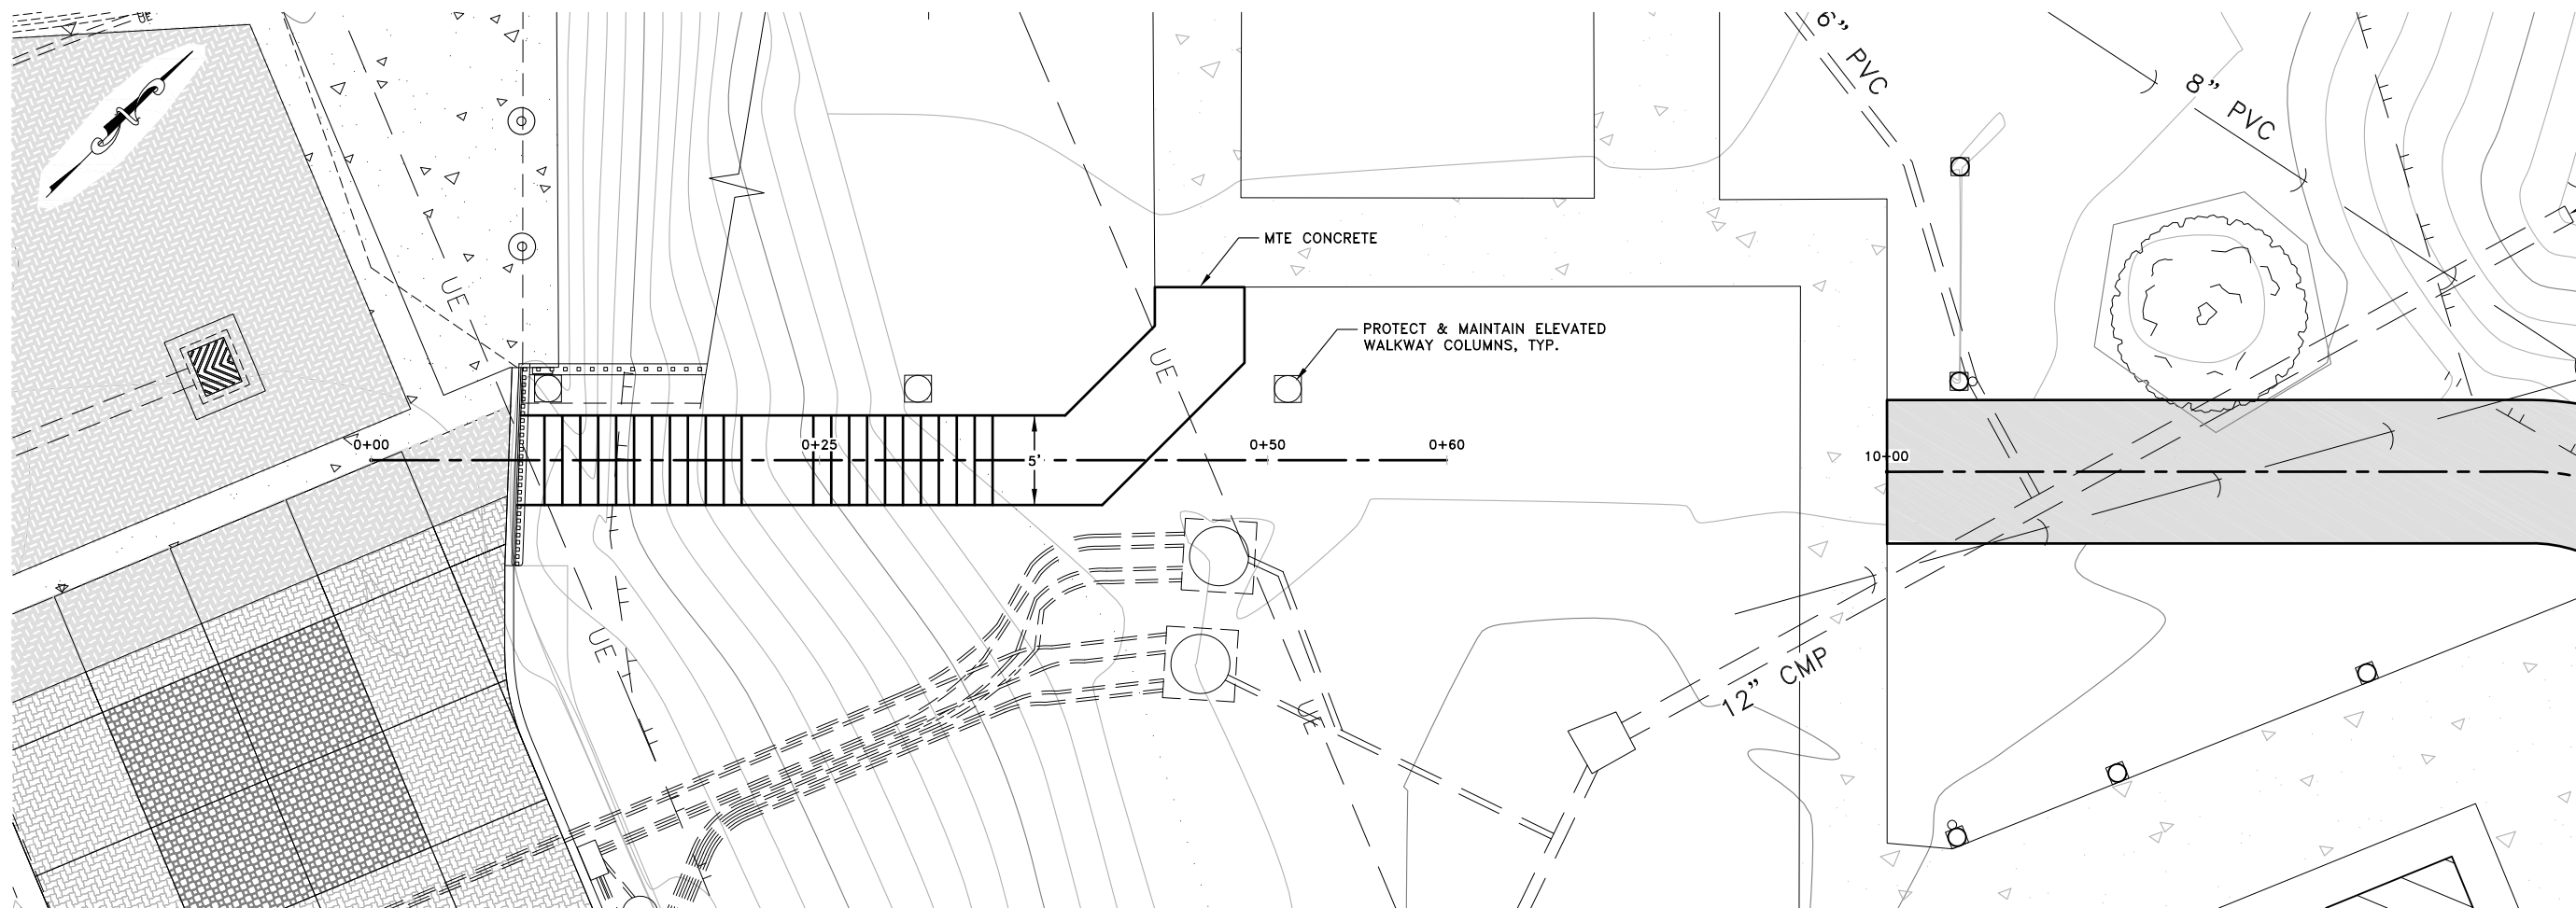
MOURANT BUILDING STAIRS - PLAN VIEW

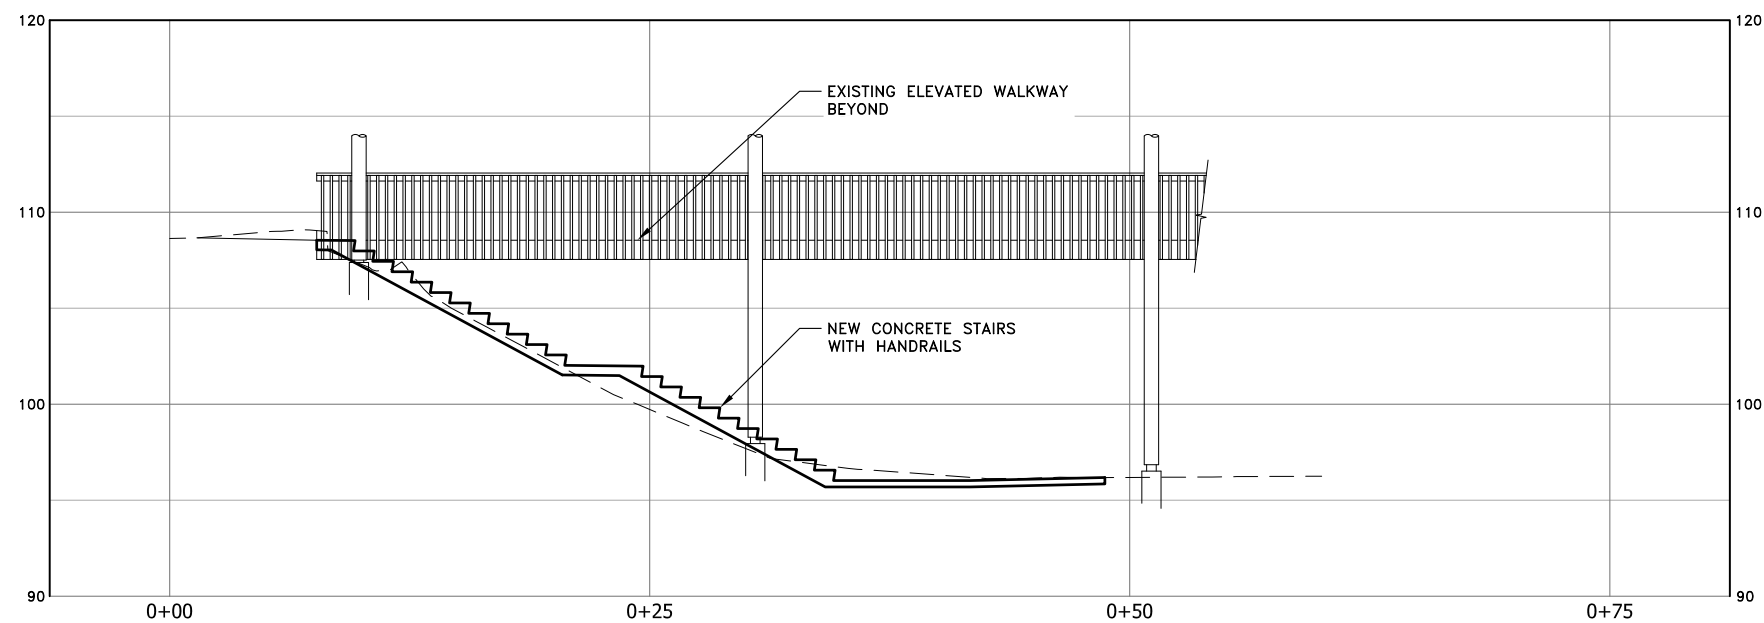
MOURANT BUILDING STAIRS - ELEVATION VIEW

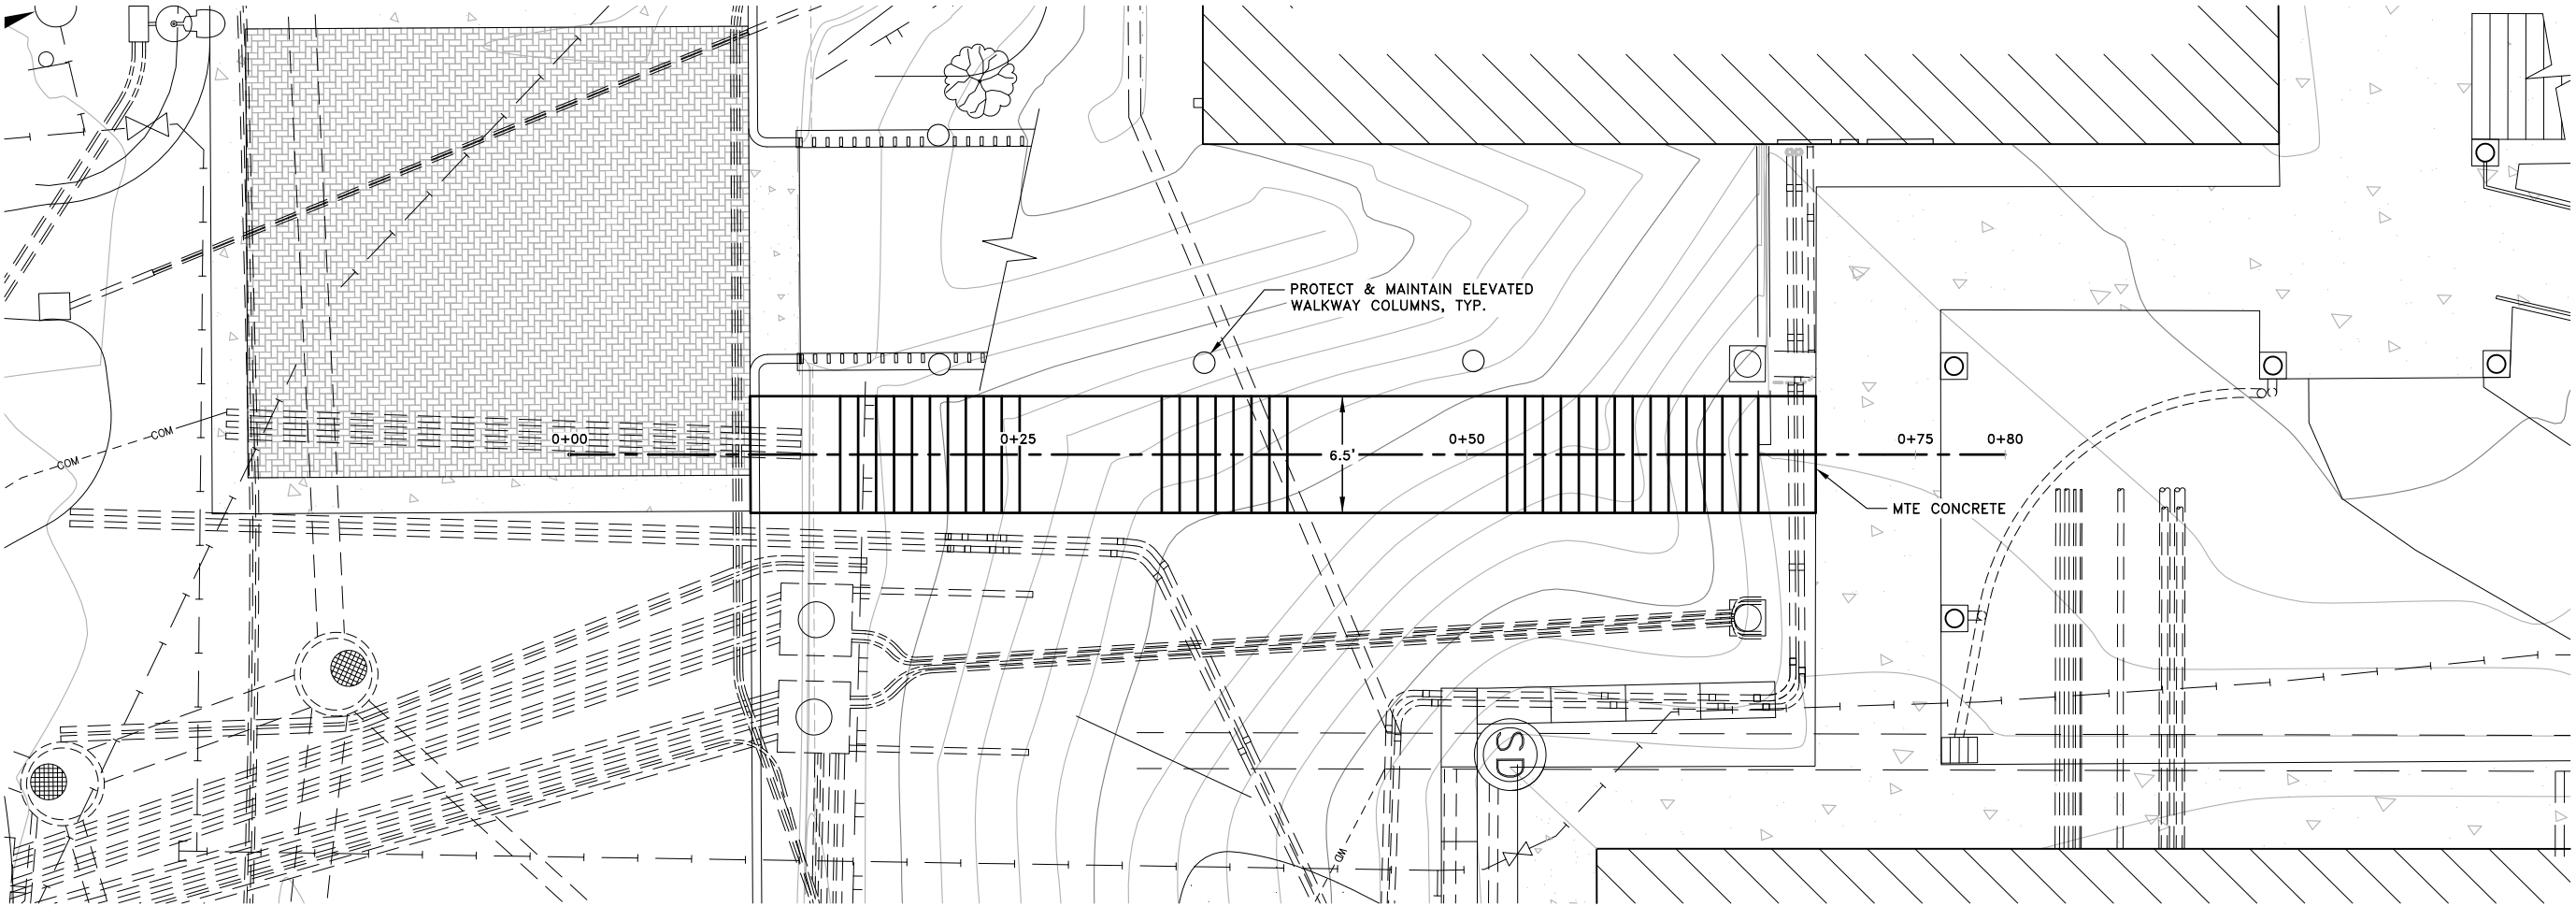
WHITEHEAD BUILDING STAIRS - PLAN VIEW

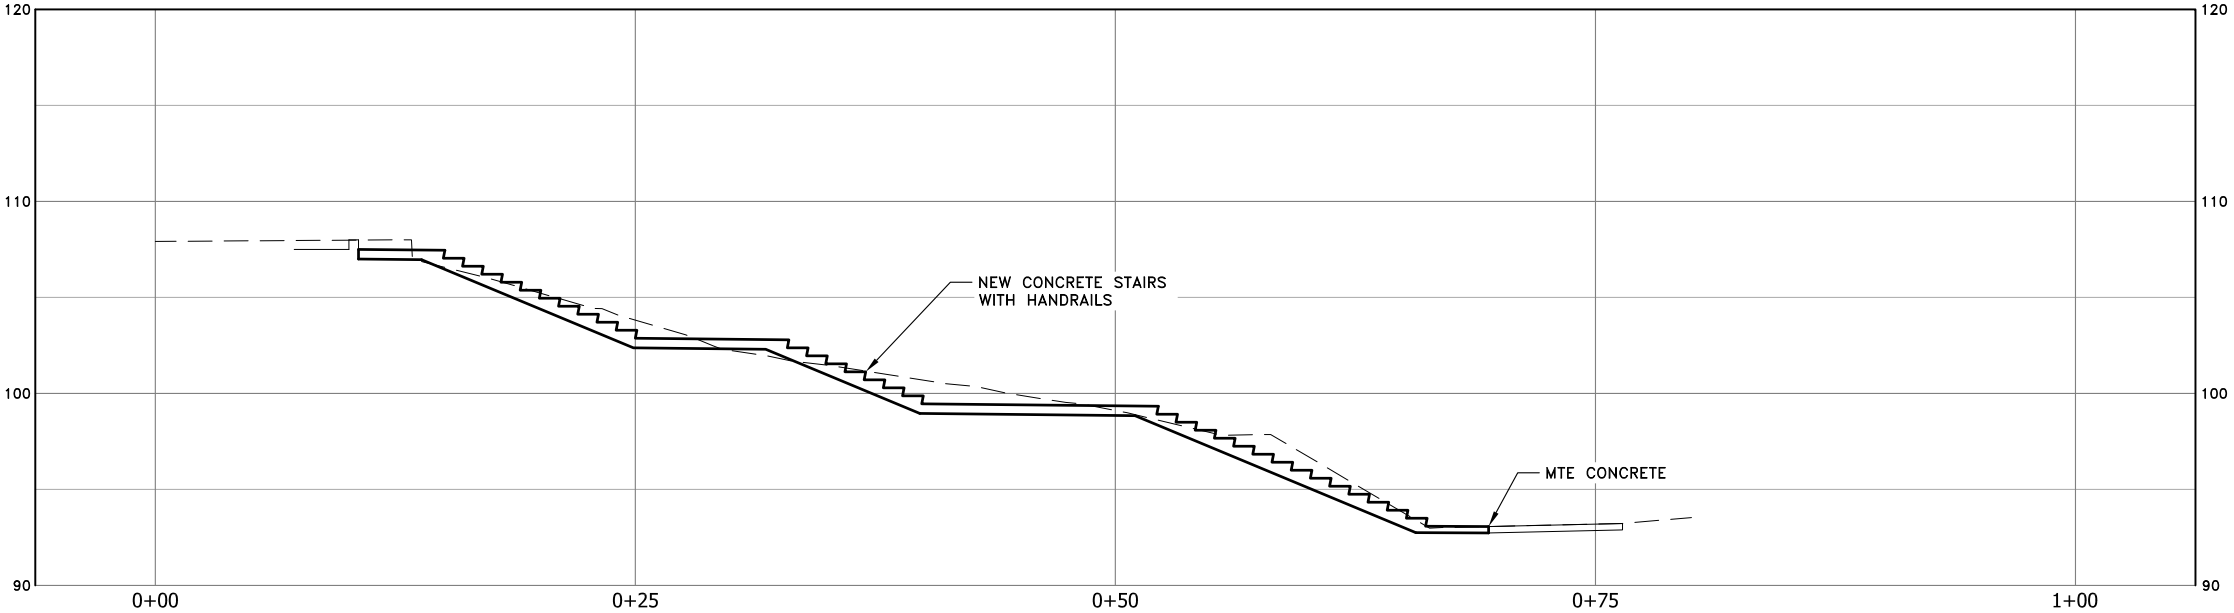
WHITEHEAD BUILDING STAIRS - ELEVATION VIEW

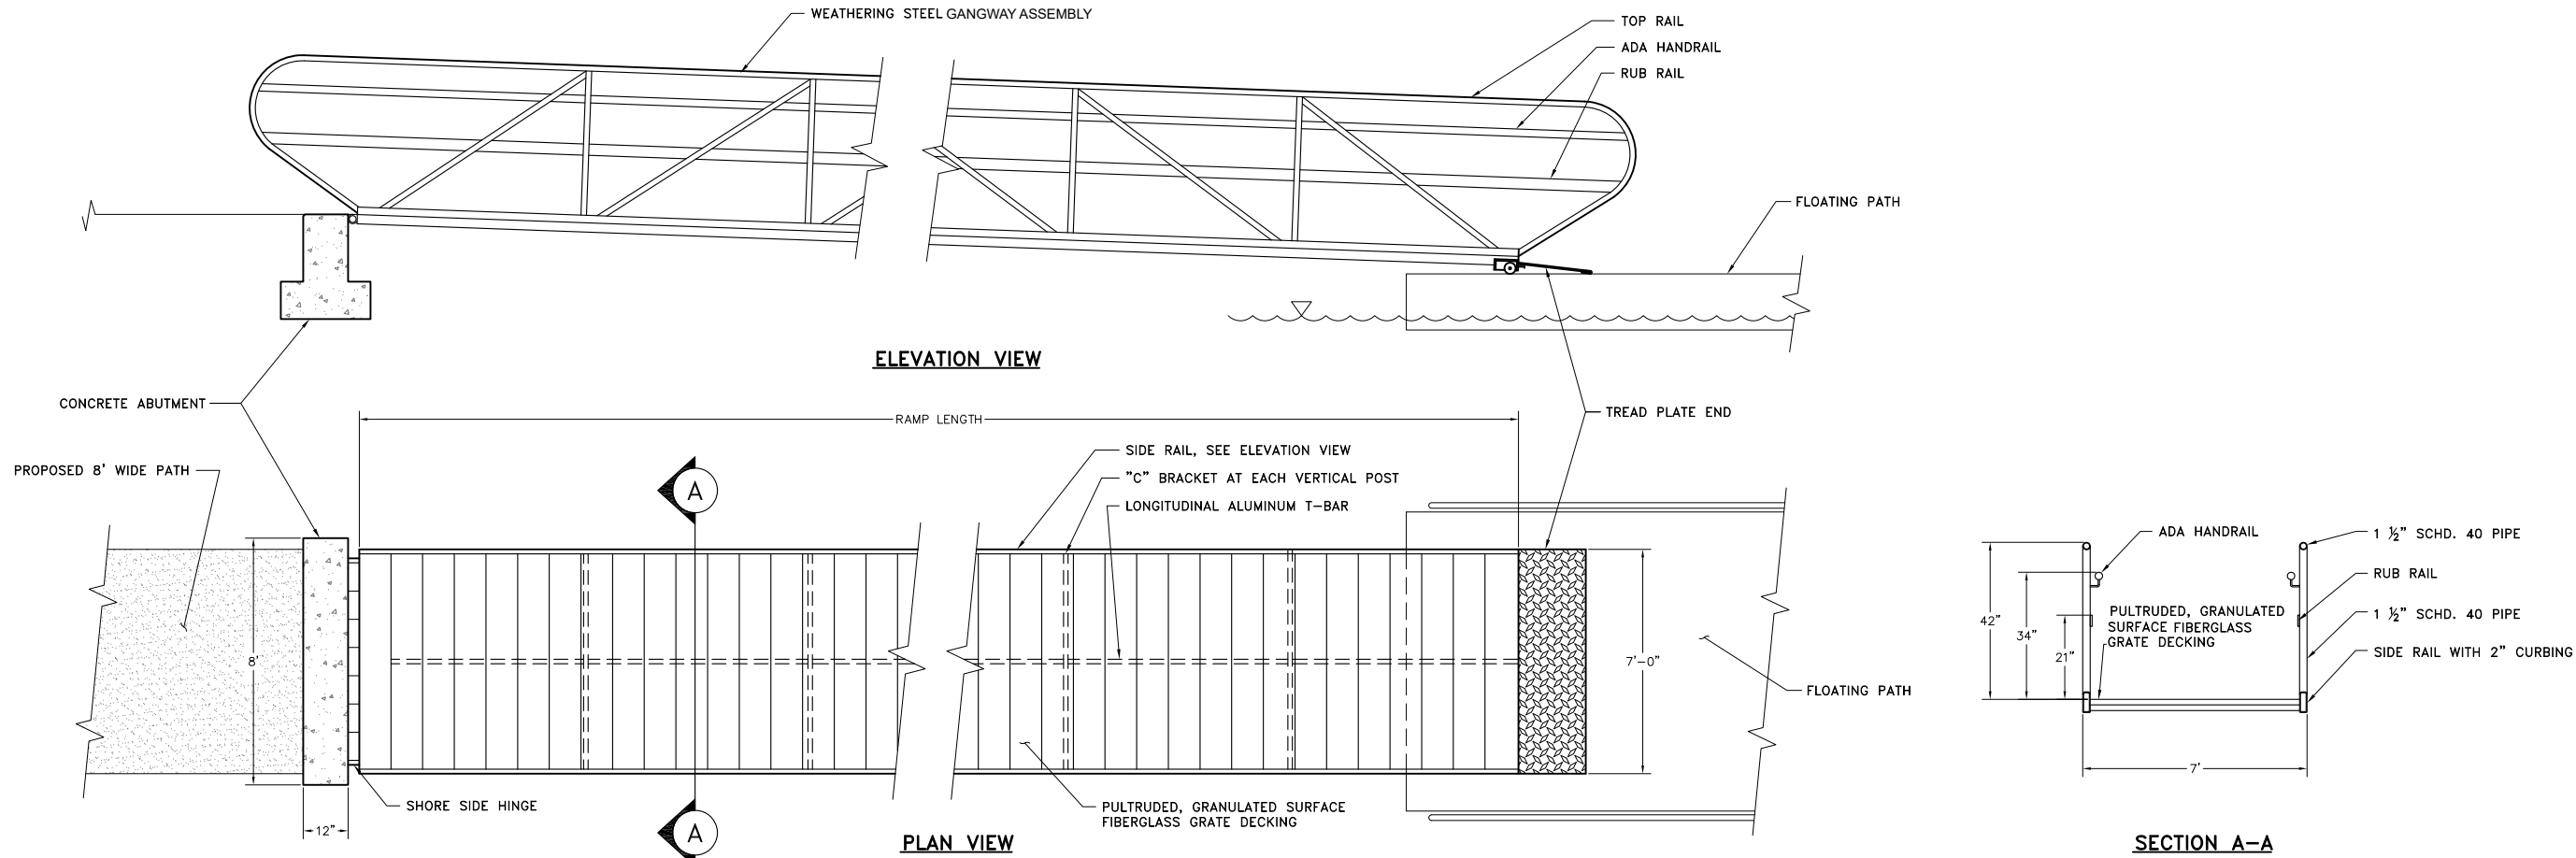
① **FLOATING PATH GANGWAY**
N.T.S.

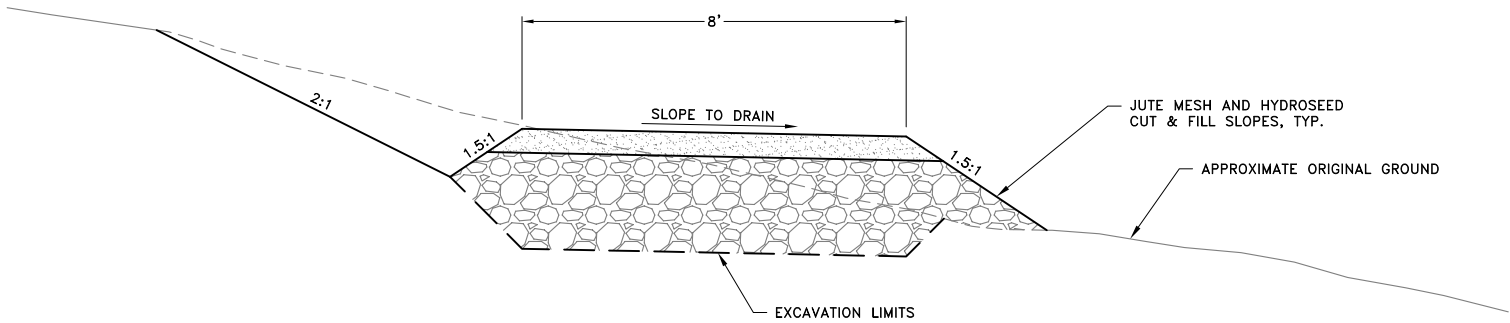
② **NEW 8' WIDE PATH**
N.T.S.

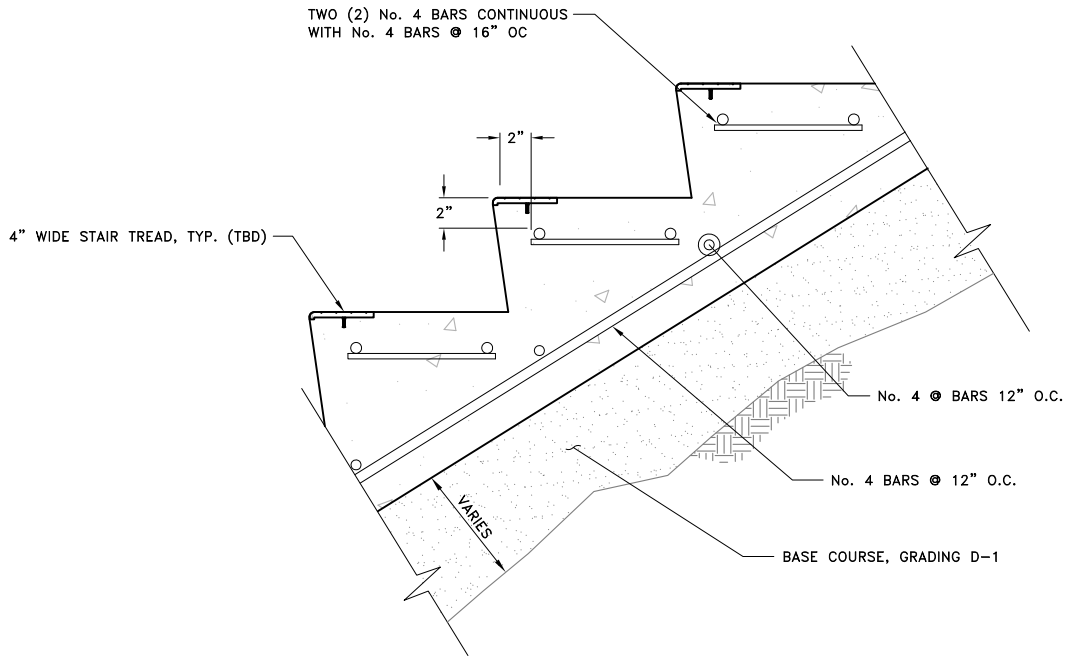
③ **CONCRETE STAIR DETAIL**
N.T.S.

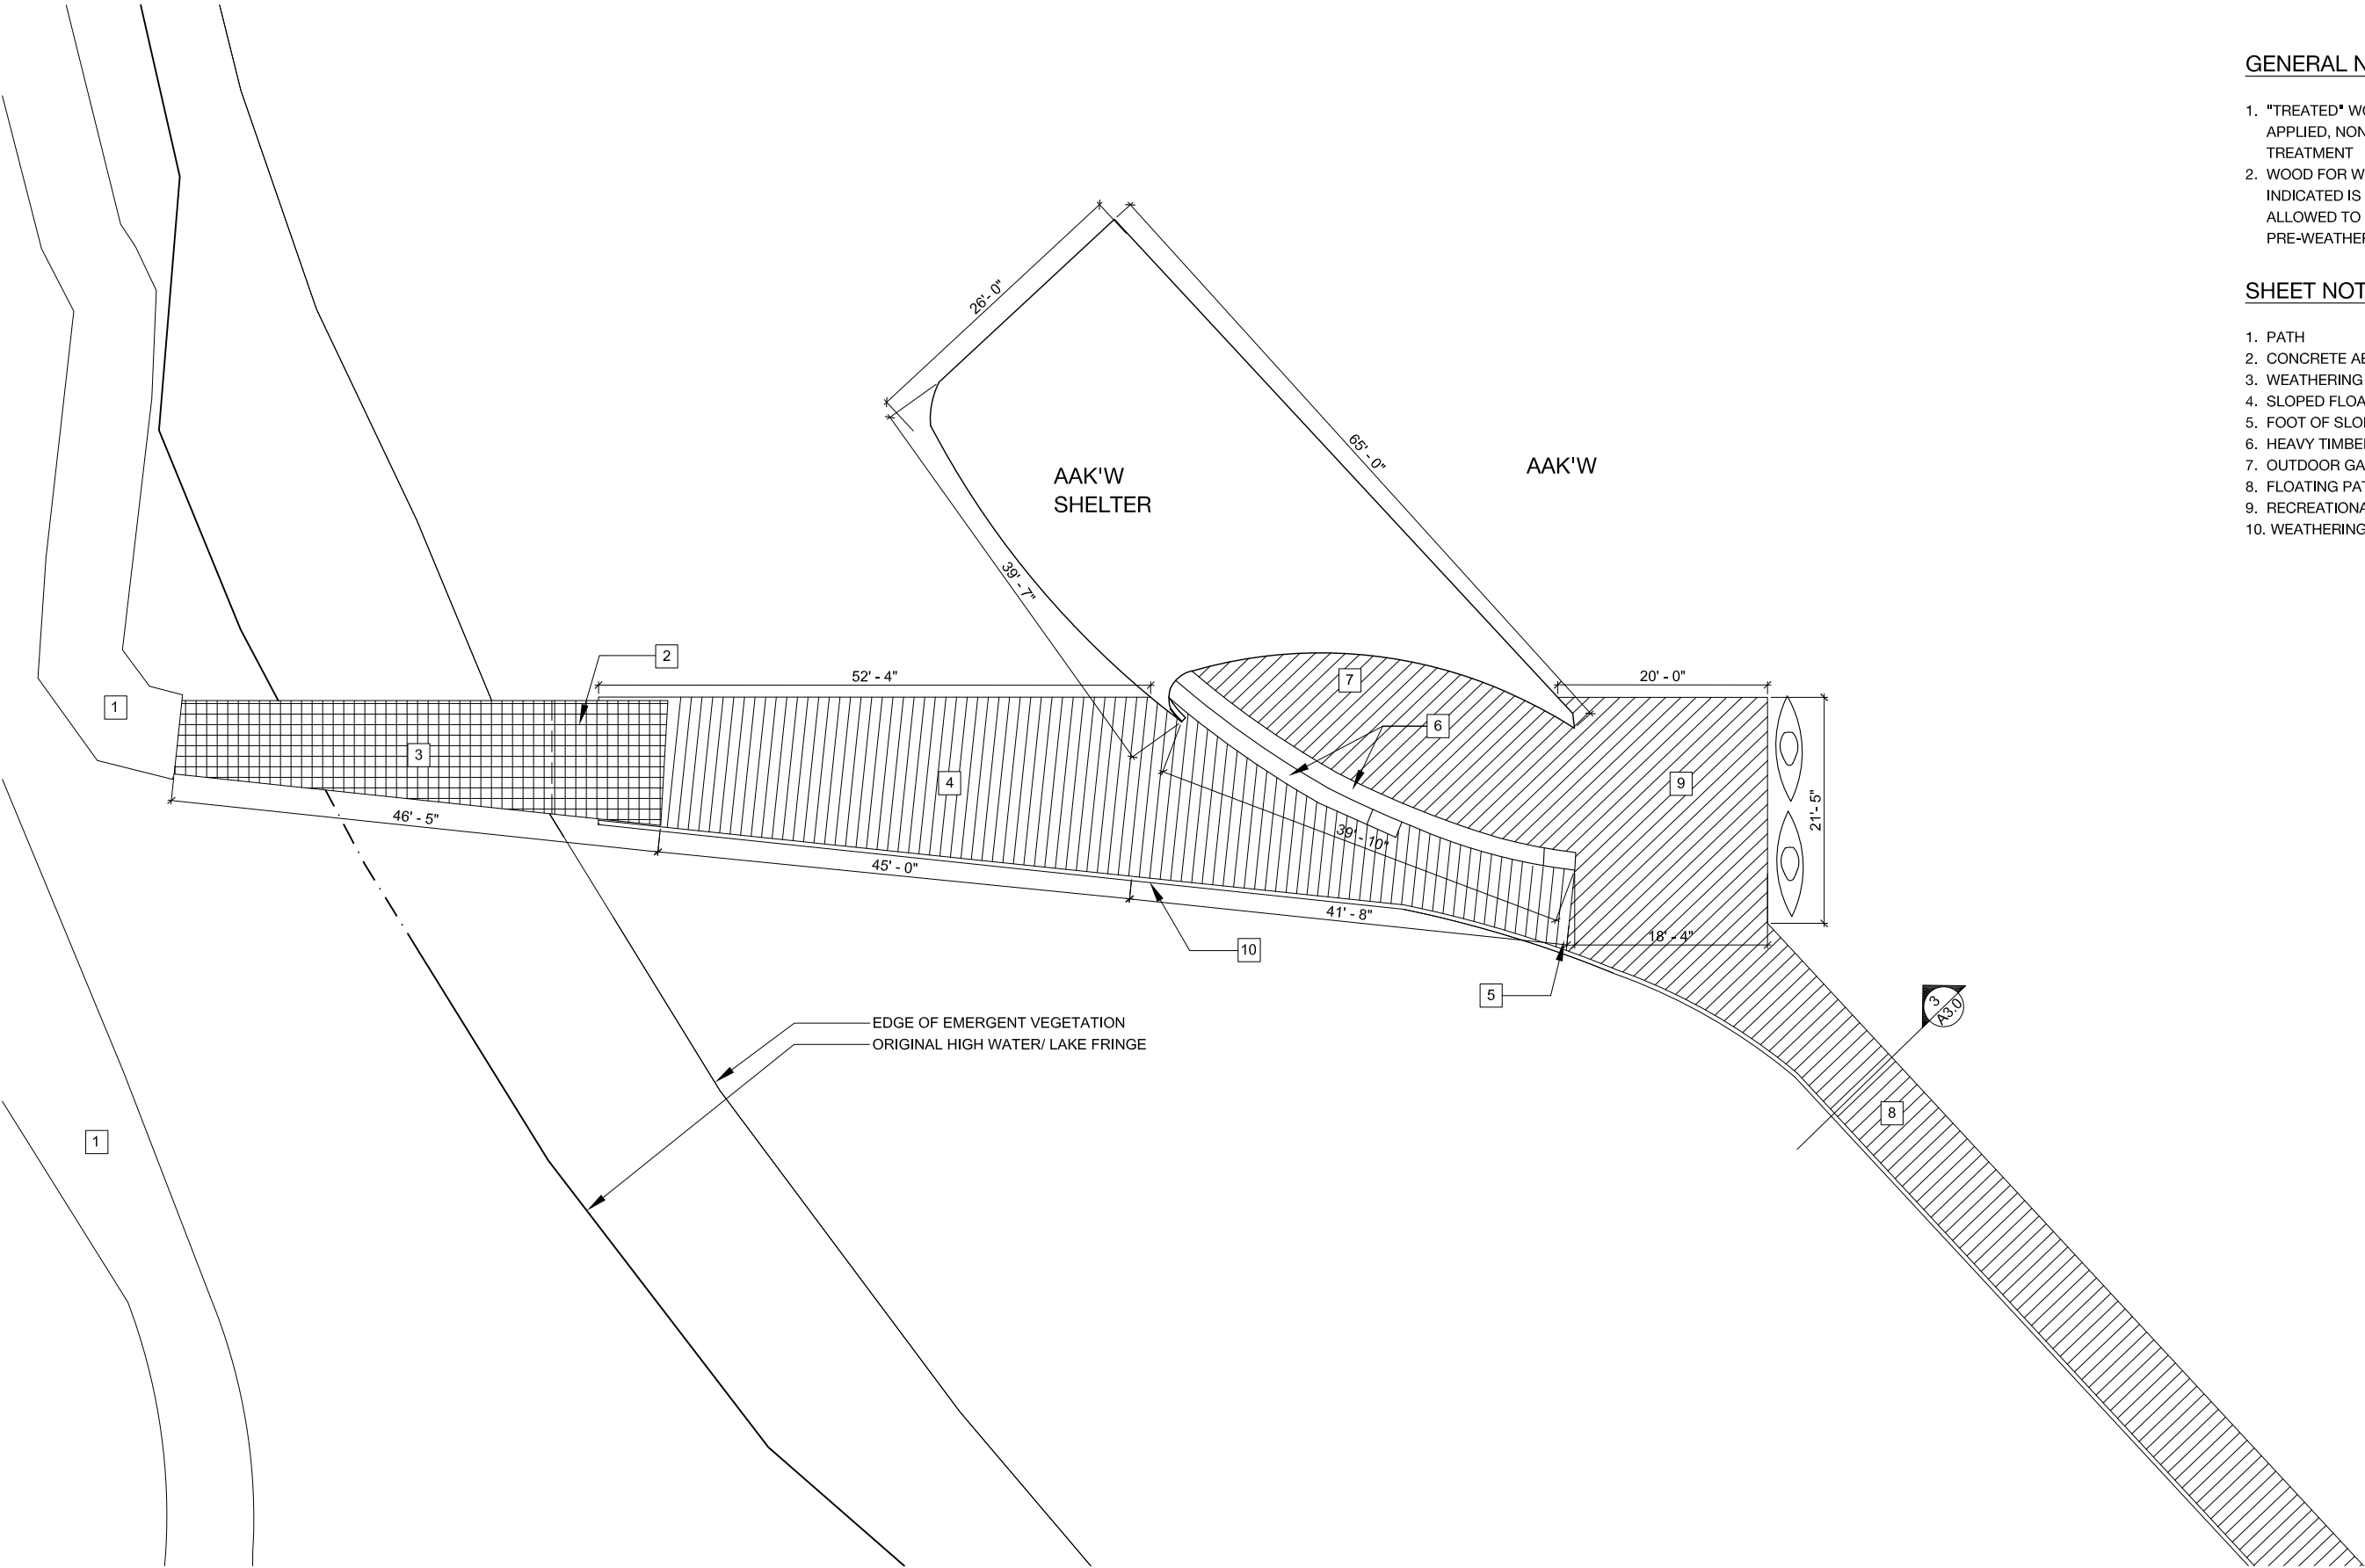
1 SITE PLAN
1/16" = 1'-0"

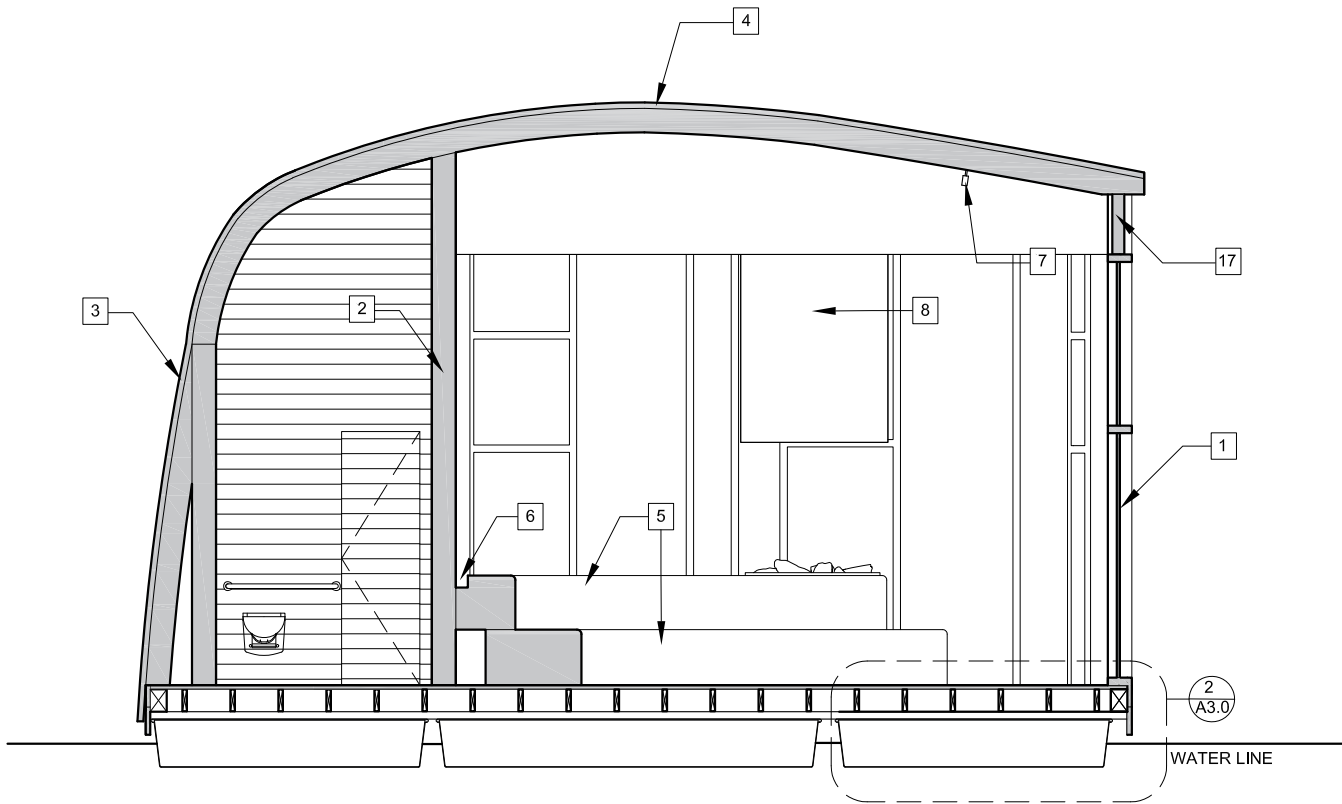
1 SECTION
3/16" = 1'-0"

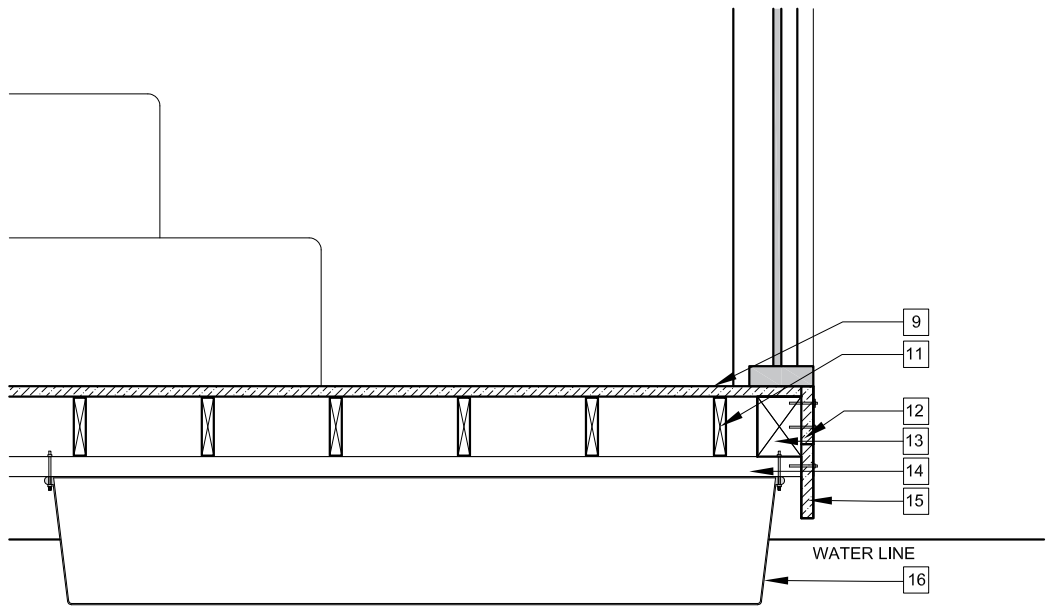
2 SHELTER DETAIL
1/2" = 1'-0"

- Foundation (floating) – closed-cell polystyrene foam filled polyethylene flotation bladders supporting a pressure treated, solid sawn timber floor framing utilizing grade 316 stainless steel connection devices and fasteners, cross anchored at multiple points with galvanized steel chain to submerged concrete anchors
- Foundation, Alternate – steel piles
- Deck, Interior – solid-sawn, treated 2x6 tongue and groove
- Deck, Exterior - pultruded, granulated surface, fiberglass grating
- Wall Framing – solid sawn wood, stick framed
- Roof Framing – custom formed, treated, glue-laminated timber
- Sheathing – solid sawn 1 X 4 wood skip-sheathing, with ¼" max gap

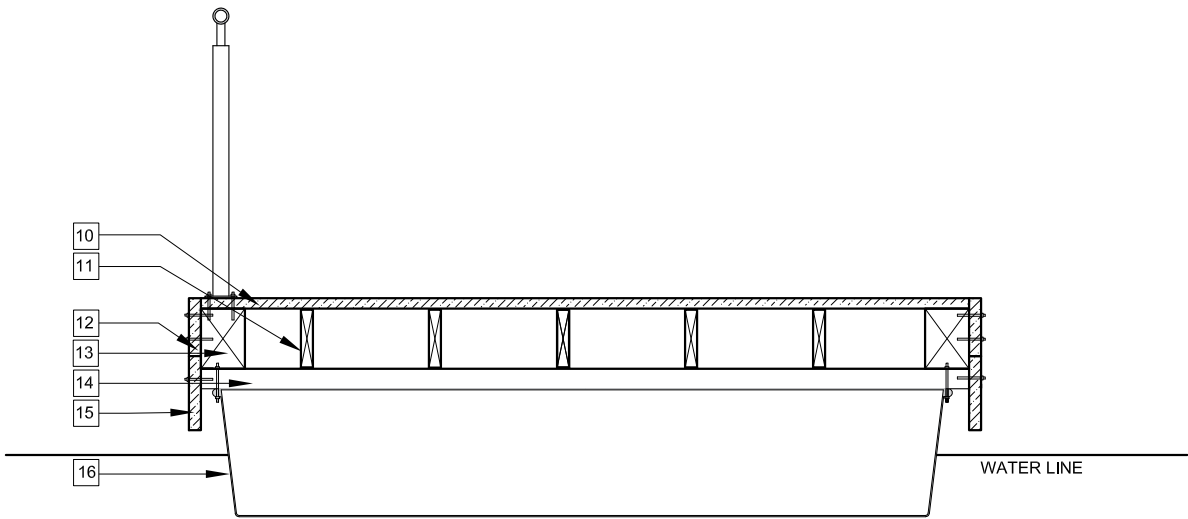
3 FLOATING PATH DETAIL
1/2" = 1'-0"

- Foundation (floating) – closed-cell polystyrene foam filled polyethylene flotation bladders supporting a pressure treated, solid sawn timber floor framing utilizing grade 316 stainless steel connection devices and fasteners, cross anchored at multiple points with galvanized steel chain to submerged concrete anchors
- Gangway – prefabricated weathering steel stringers and guard rail
- Deck - pultruded, granulated surface, fiberglass grating

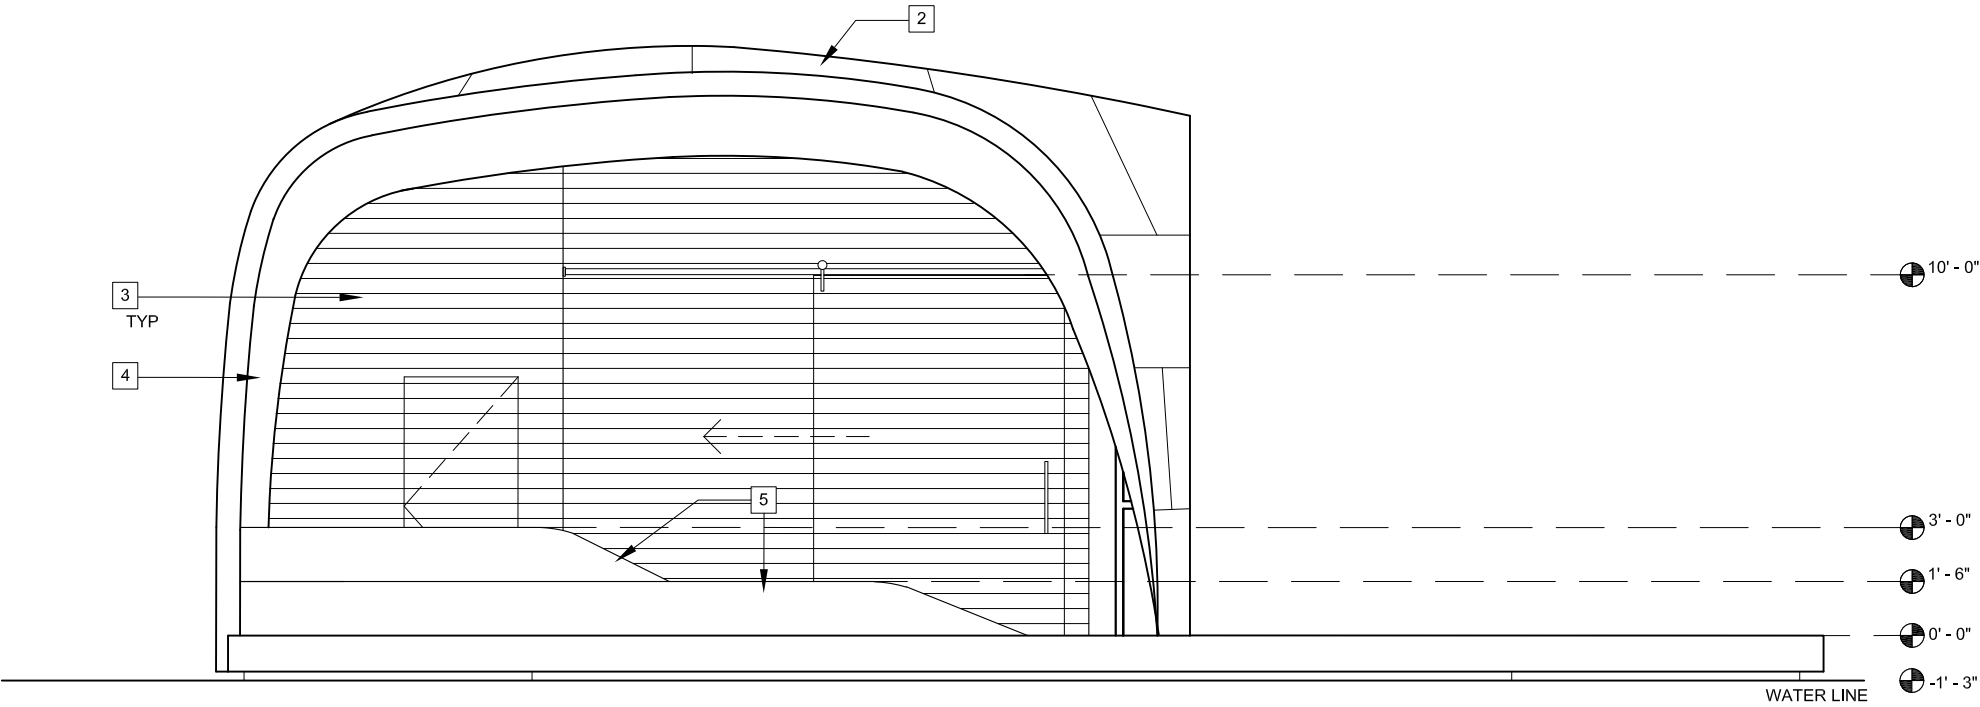
1 EAST ELEVATION
3/16" = 1'-0"

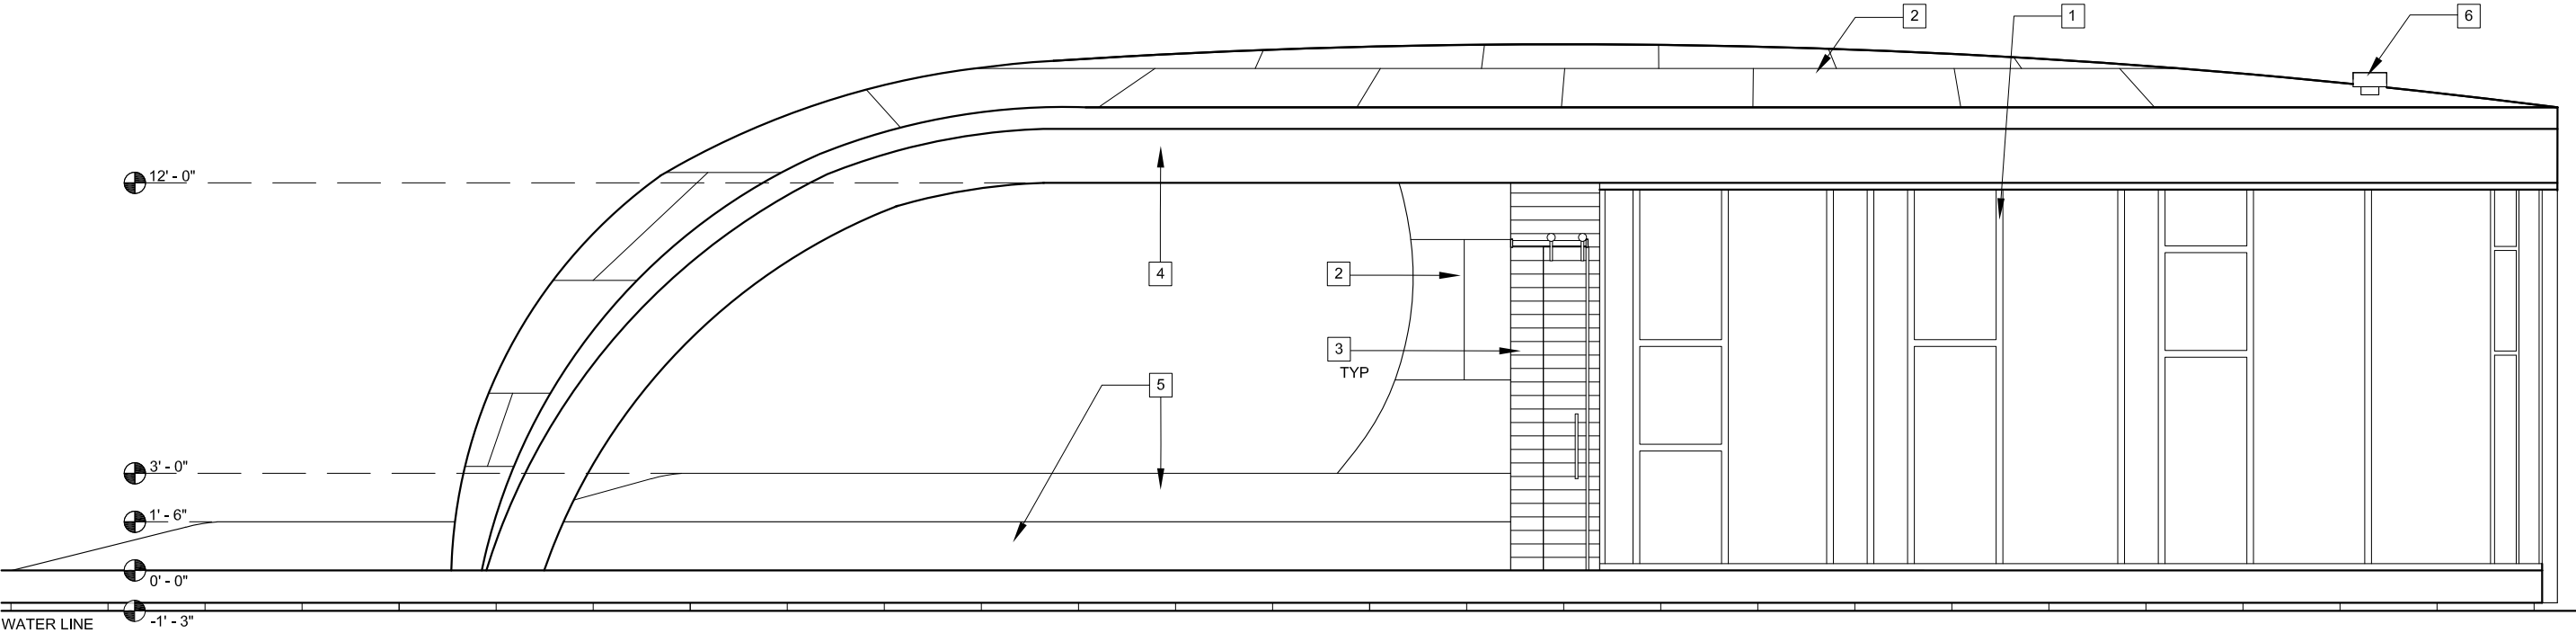
2 NORTH ELEVATION
3/16" = 1'-0"

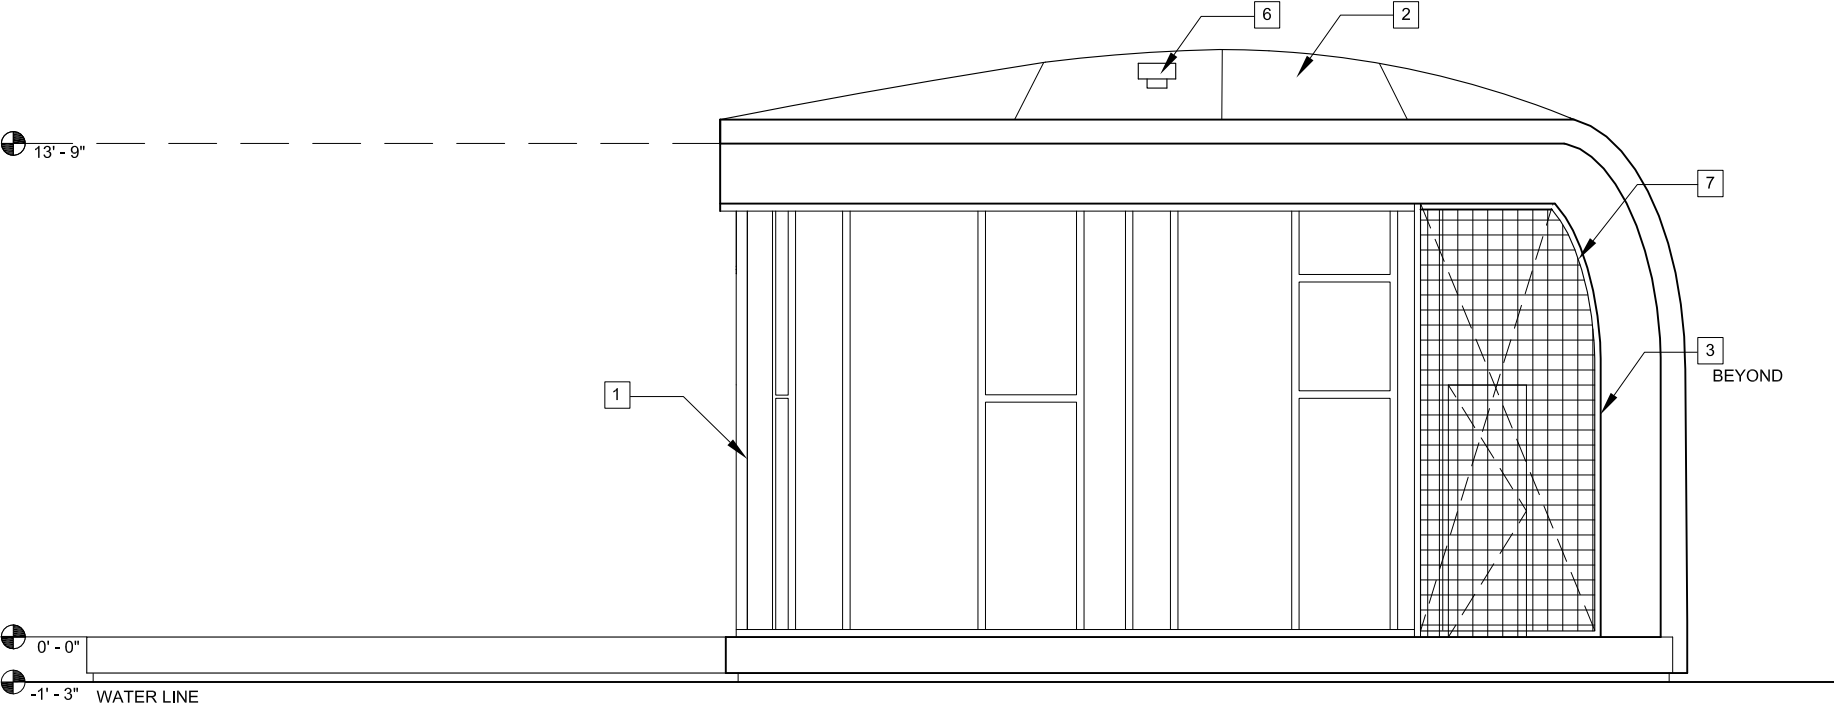
1 WEST ELEVATION
3/16" = 1'-0"

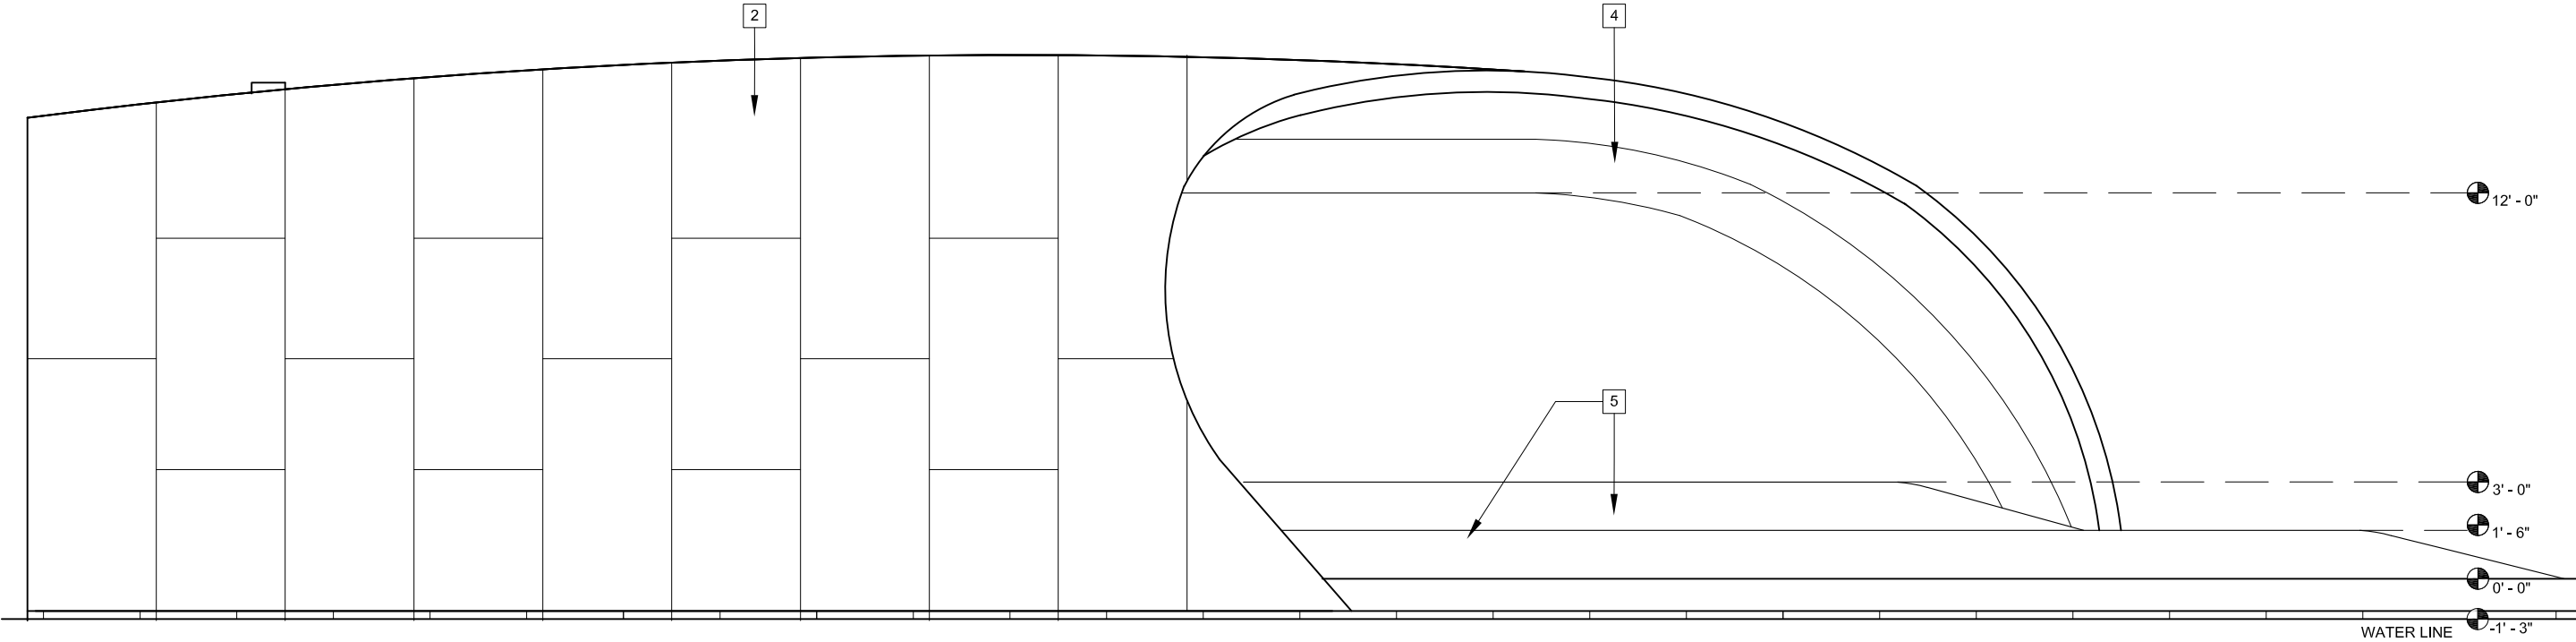
2 SOUTH ELEVATION
3/16" = 1'-0"
