UAS AAK'W SHORELINE IMPROVEMENT PROJECT CONCEPT/SCHEMATIC DESIGN SUBMITTAL

24 May 2019

Project: UAS Aak'w Shoreline Improvement Project
UAS Contract/Project #2015-08

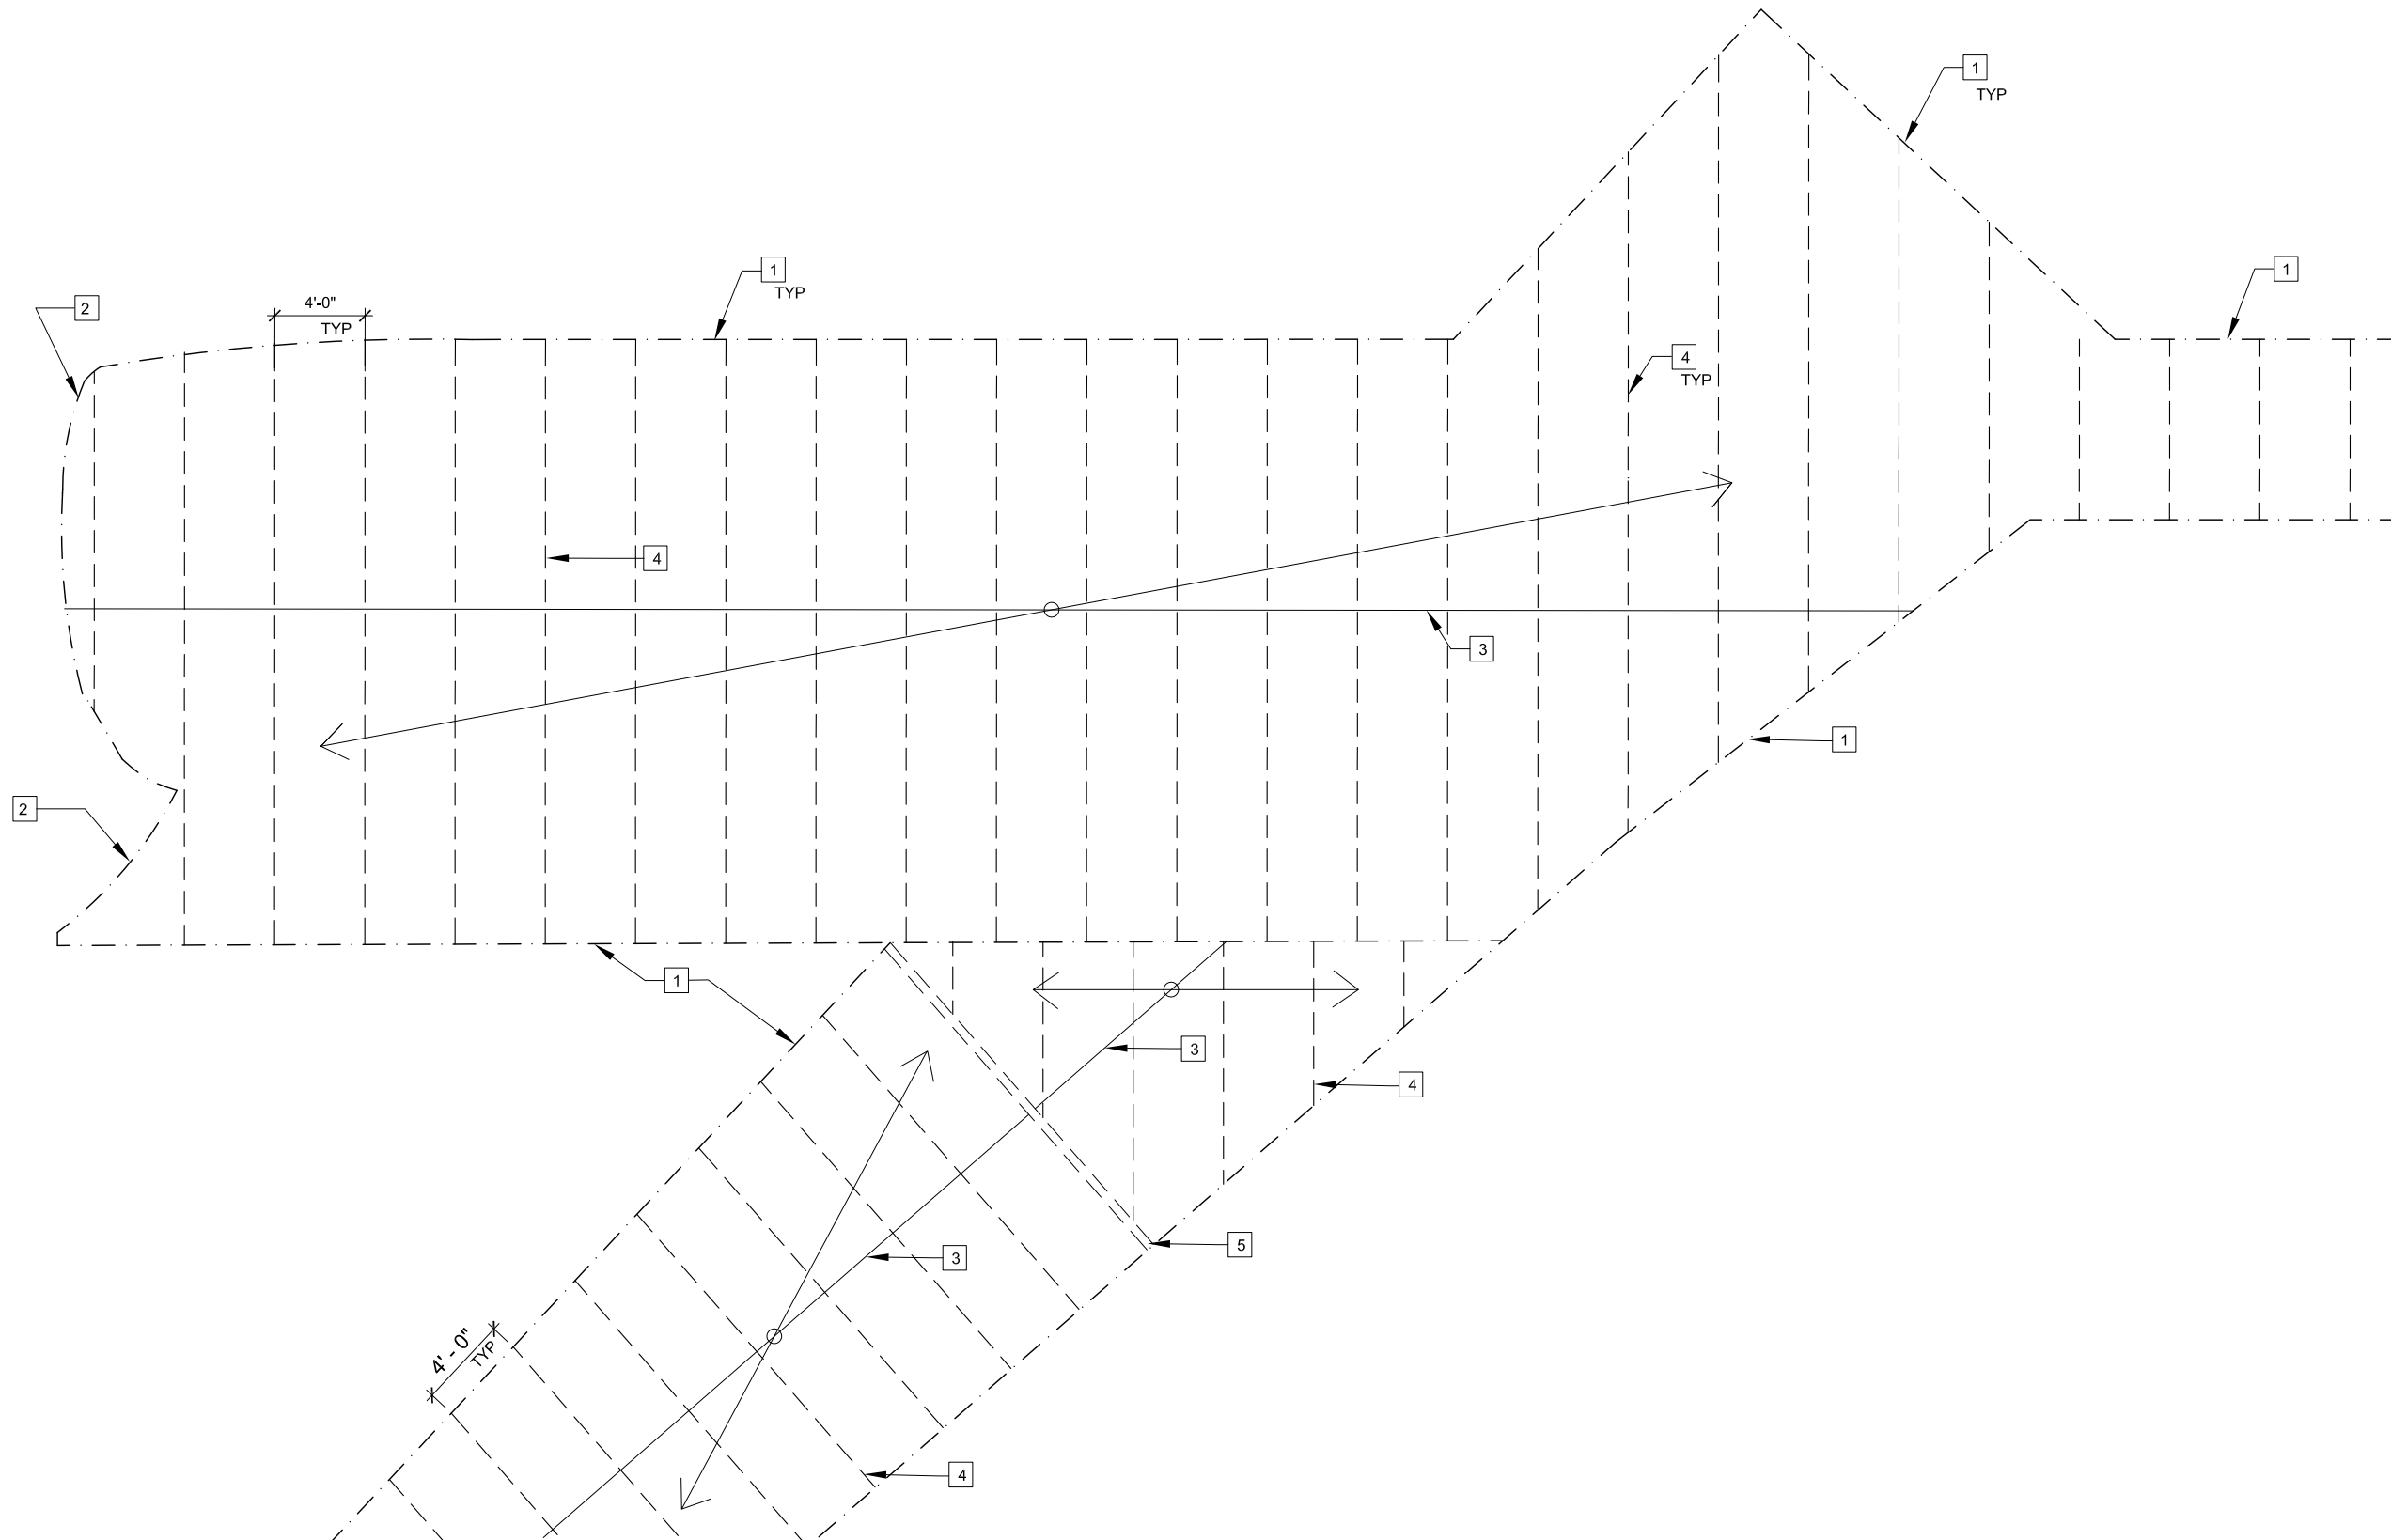
1 DECK FRAMING PLAN
1/8" = 1'-0"

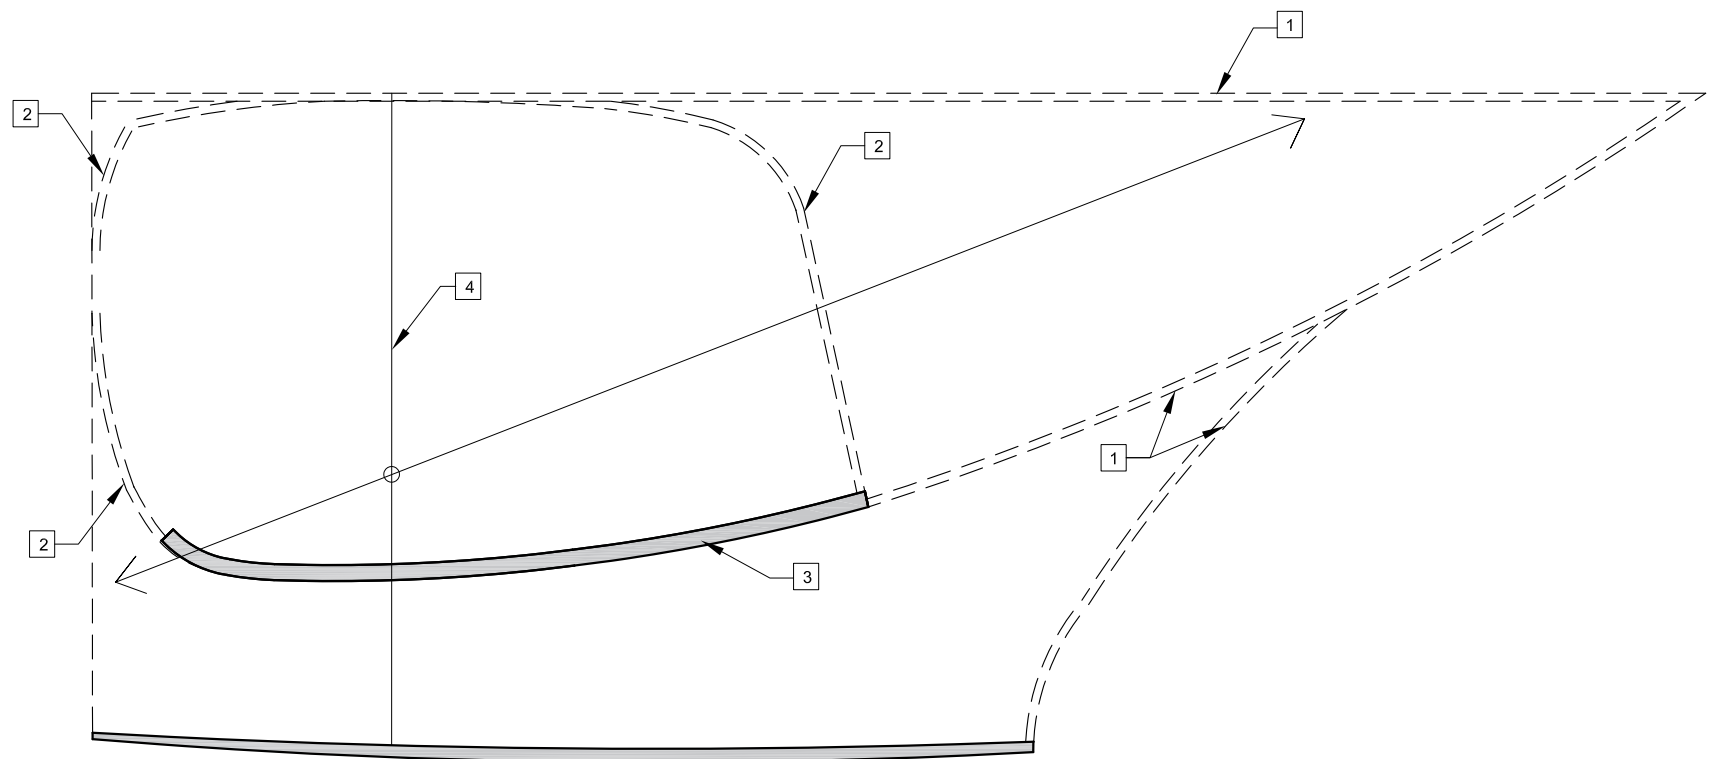
1 ROOF FRAMING PLAN

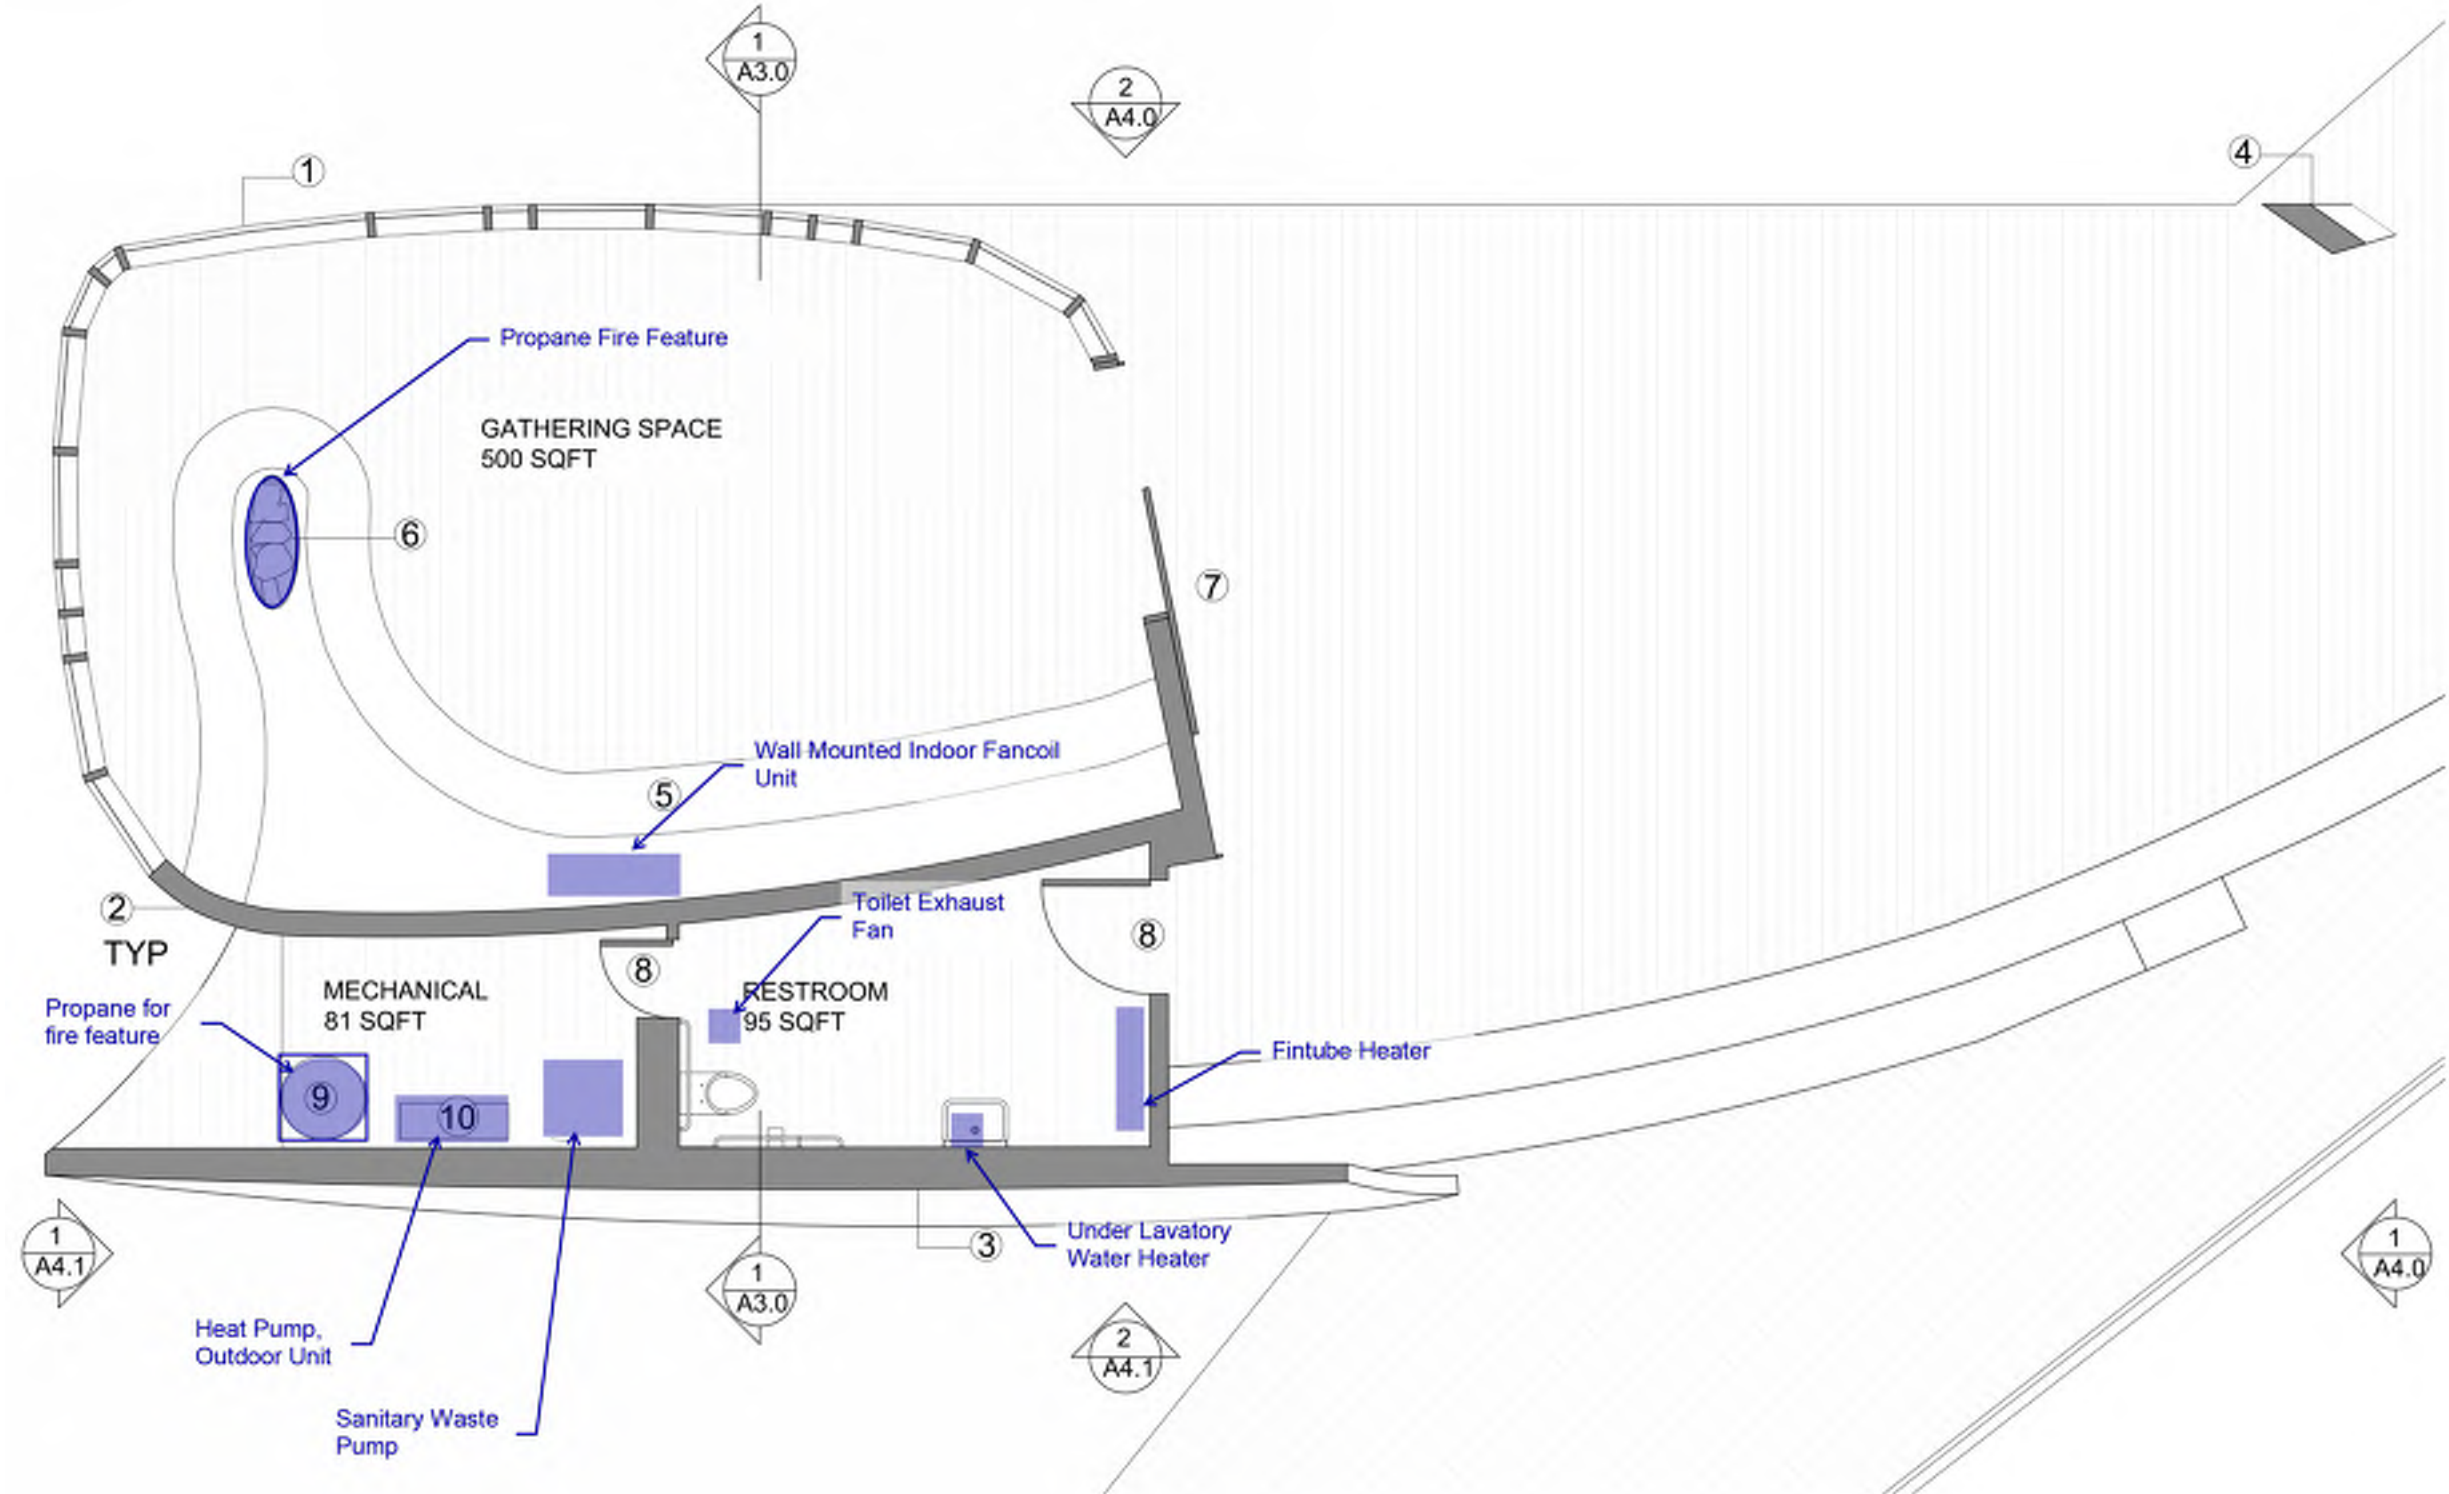
1
A2.0
FLOOR PLAN
3/16" = 1'-0"

1
A4.0
FLOOR PLAN WITH ADDITIONAL MECHANICAL NOTES.

Plumbing for this space will consist of a lavatory and toilet located in the restroom as well as a hose bib located on the exterior of the structure. As noted in the civil plans, it will be necessary to route both a 1" water line to the building as well as a 2" pressurized waste line. The pressurized waste line will be routed to an existing sanitary sewer manhole located on the northwest corner of the Mourant Building. The plumbing that will be exposed in the connection between the shoreline and the structure will be routed adjacent to the deck and will require both heat trace, insulation and protective covering to prevent freezing during winter months and damage to the pipes. A 2" vent will also be required to penetrate the structure dock building and will be routed from the Sump Pump that will be located in the mechanical room.

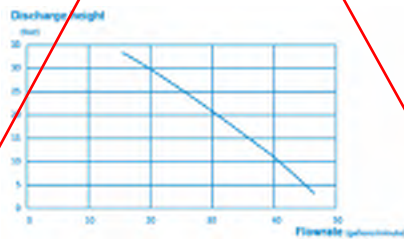
Flow curve

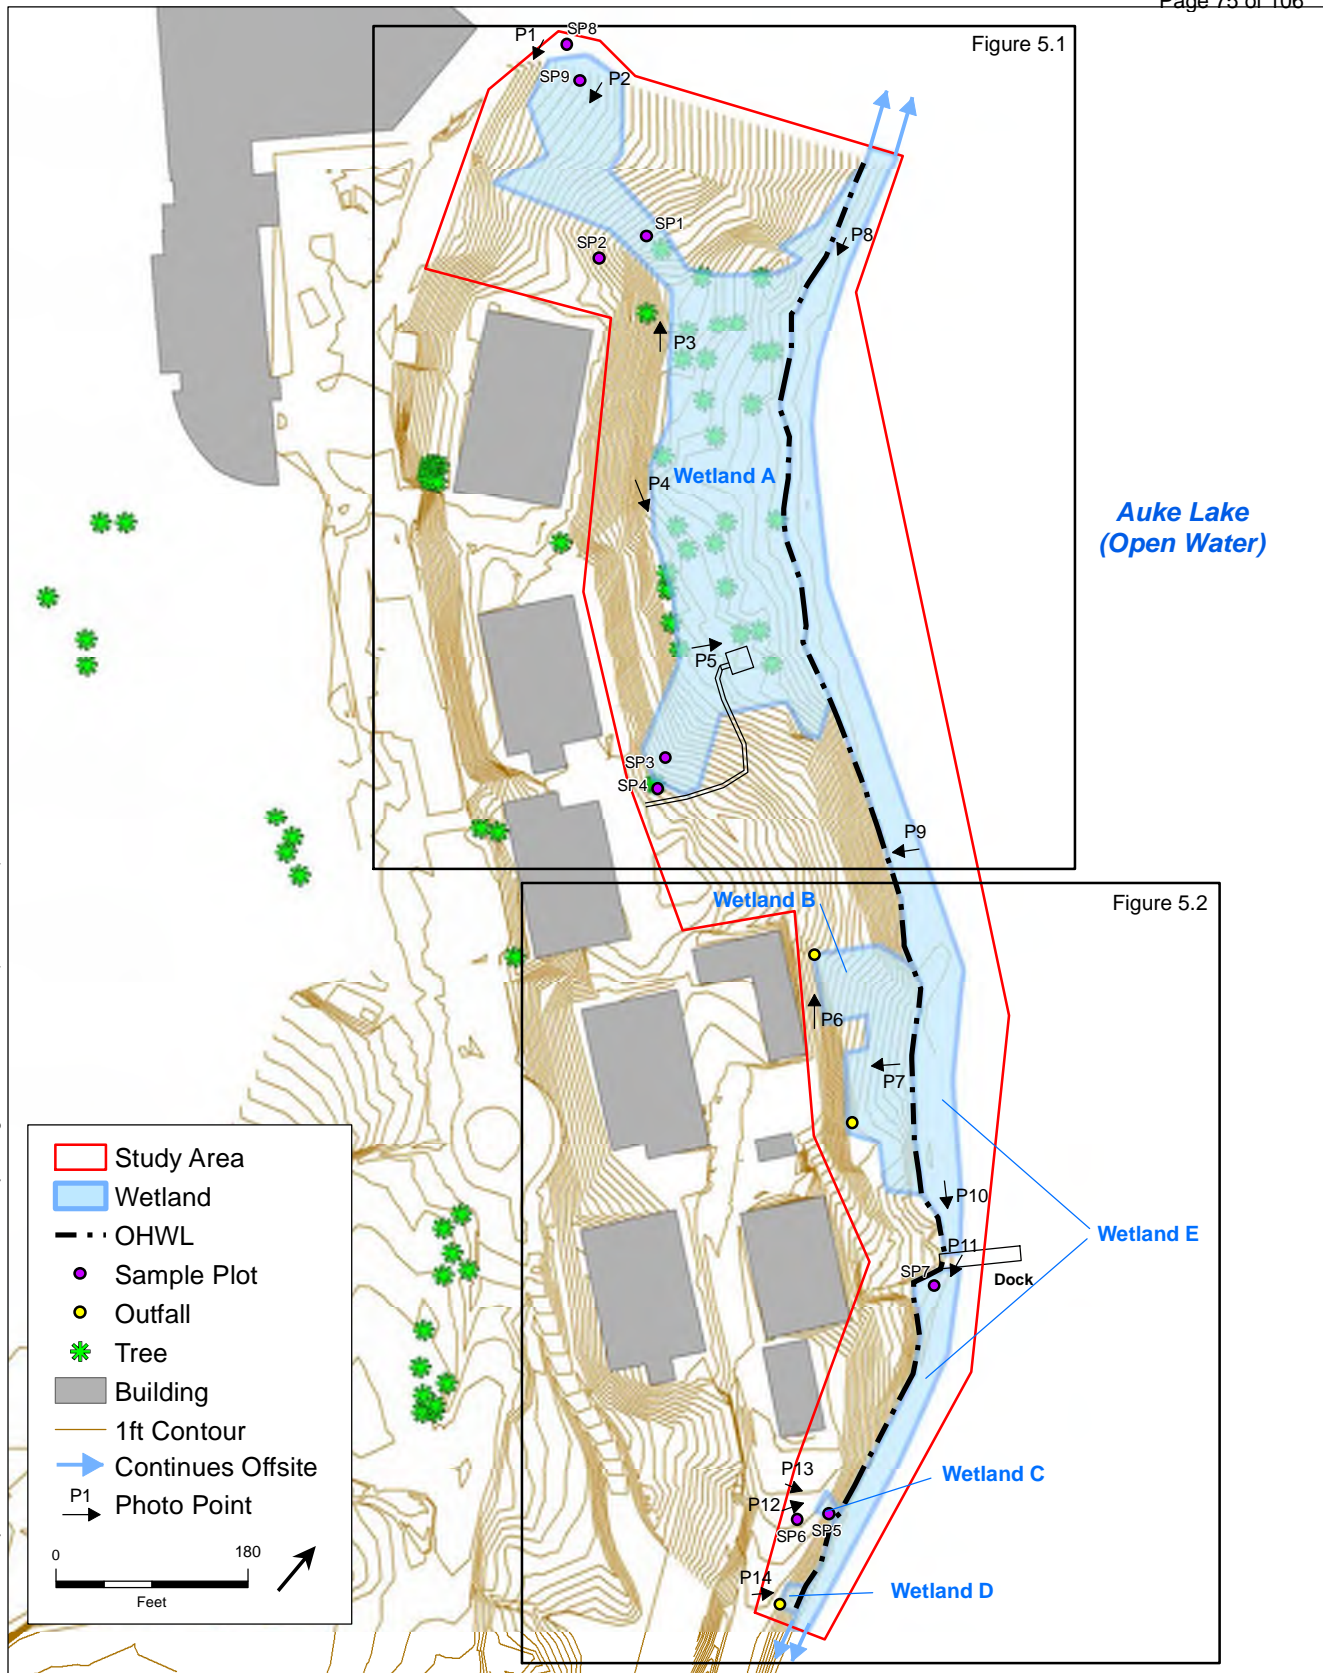
Figure 5**Wetland Delineation Overview**

Figures are located in Appendix A. Photo points are shown on Figure 5 (Appendix A). Ground-level color photographs of the wetland and upland areas were taken to characterize typical conditions and are located in Appendix B. All photos were taken during field investigations. Wetland determination data forms are located in Appendix C.

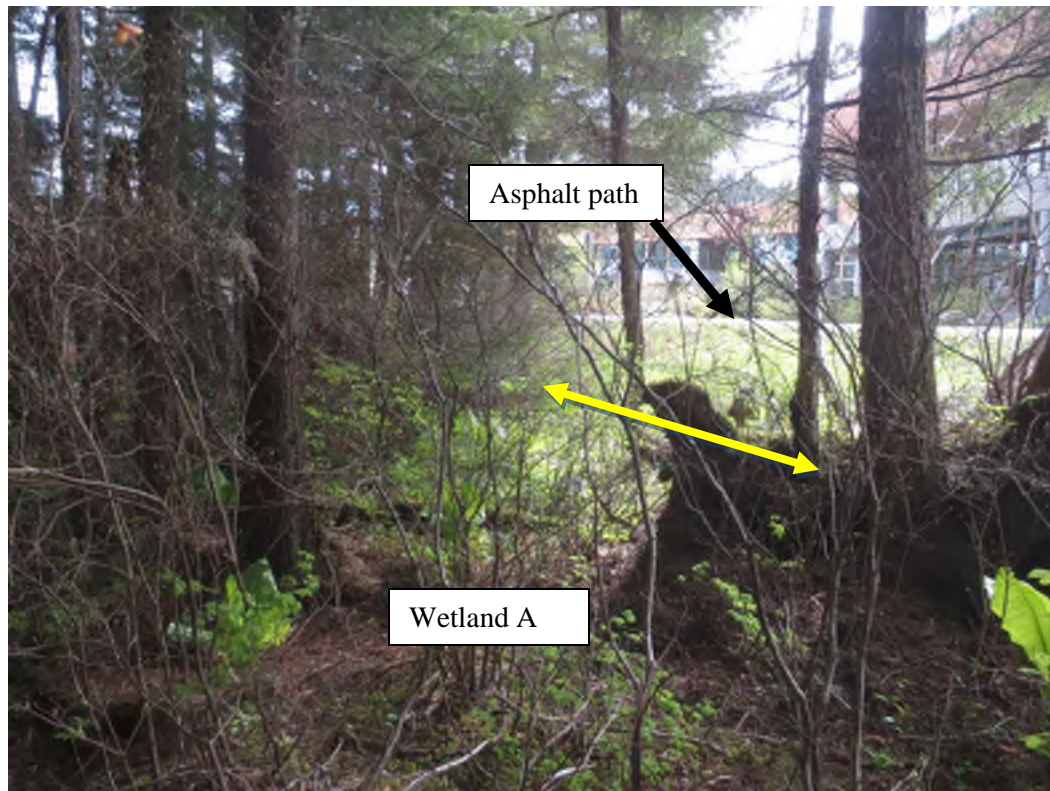
Photograph 1. Looking south at the northwest boundary of Wetland A (yellow line), at the base of an asphalt path embankment seen in the upper right part of the photo (April 2016).

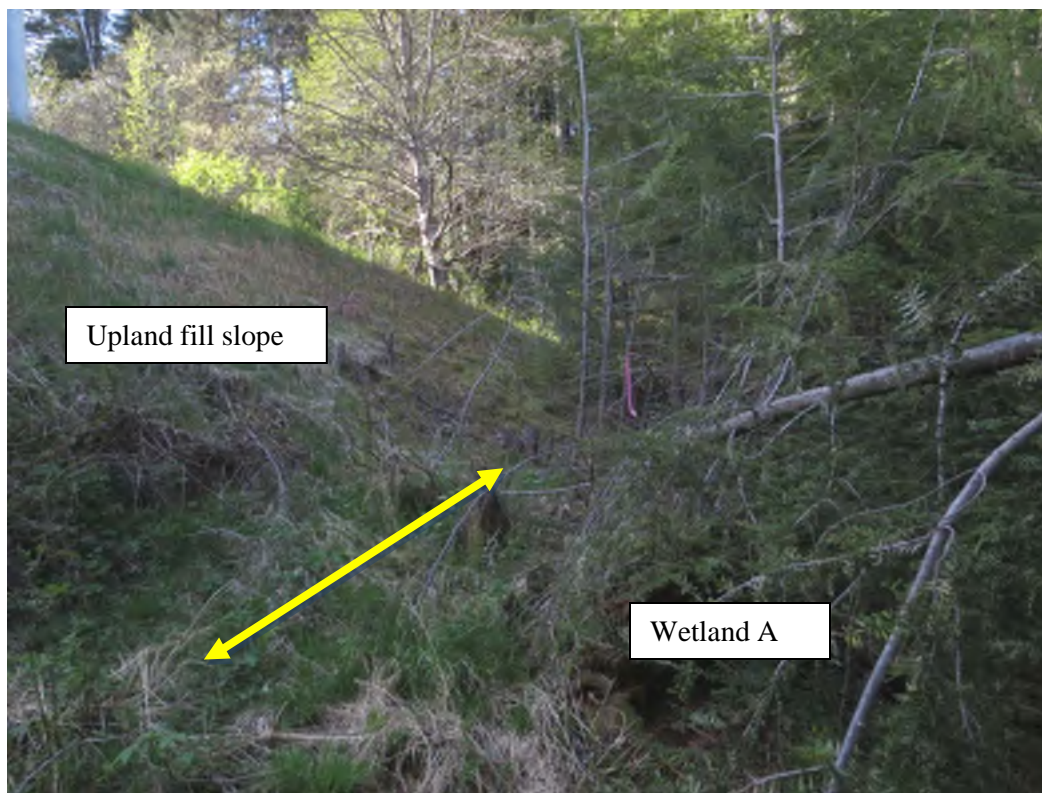
Photograph 3. Looking northwest at the western boundary of Wetland A (approximated by the yellow line). Note steep fill slope on the left side of the photo (April 2016).

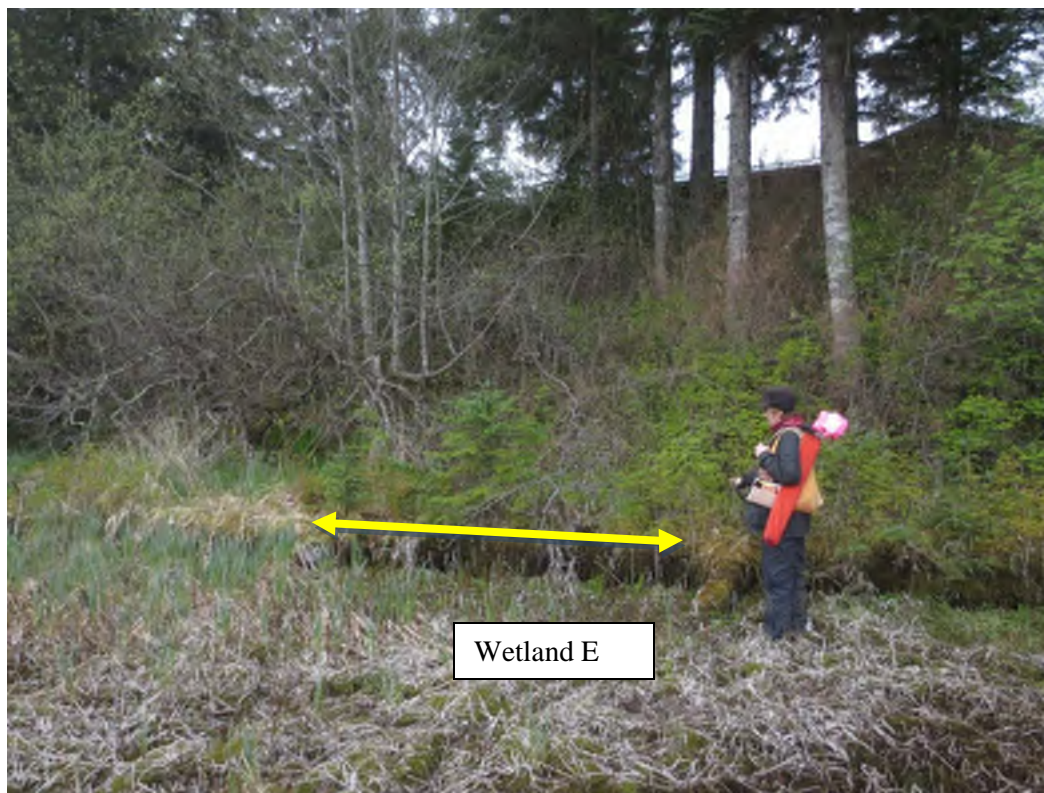
Photograph 9. The OHWL of Auke Lake (approximated by the yellow line) and Wetland E in the foreground; upland forest in the background (April 2016).
